Poole Creek

Macro Stream Assessment Report

Summer 2009

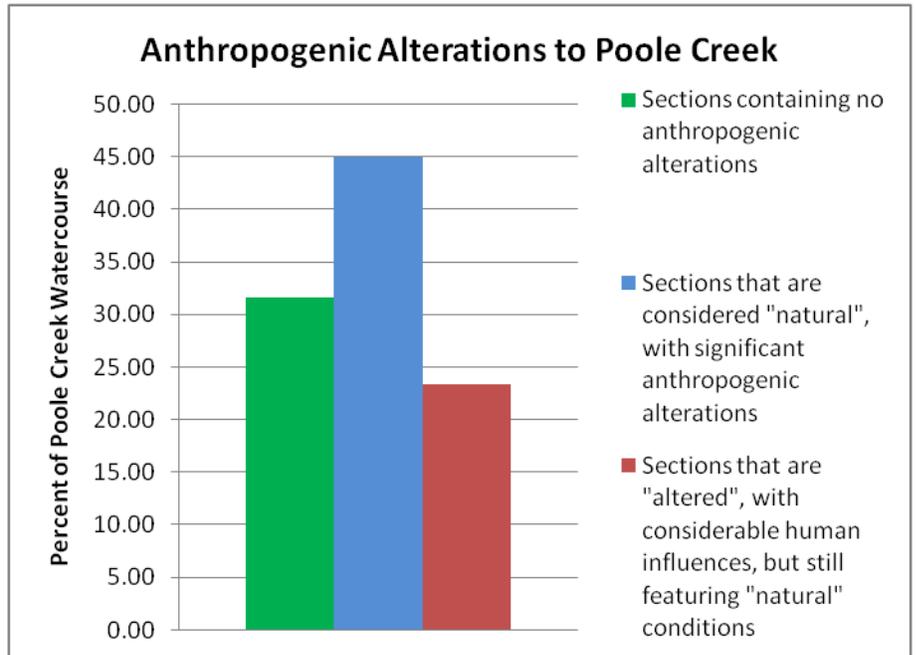
Chart 1: Anthropogenic Alterations to Poole Creek

considerably natural and provide significant vegetation, wildlife and fish habitat. Anthropogenic alterations to the creek do not only include changes to the creek’s channel itself, but also the riparian vegetation found along the banks of Poole Creek. Over 31 percent of Poole Creek was considered to have no anthropogenic alterations, with the remainder of the creek being divided between two other classifications noted in Chart 1 below. The fourth category, which is not shown in the graph, is highly altered with few areas considered natural environments. It is not in the graph because these conditions were not found along Poole Creek.

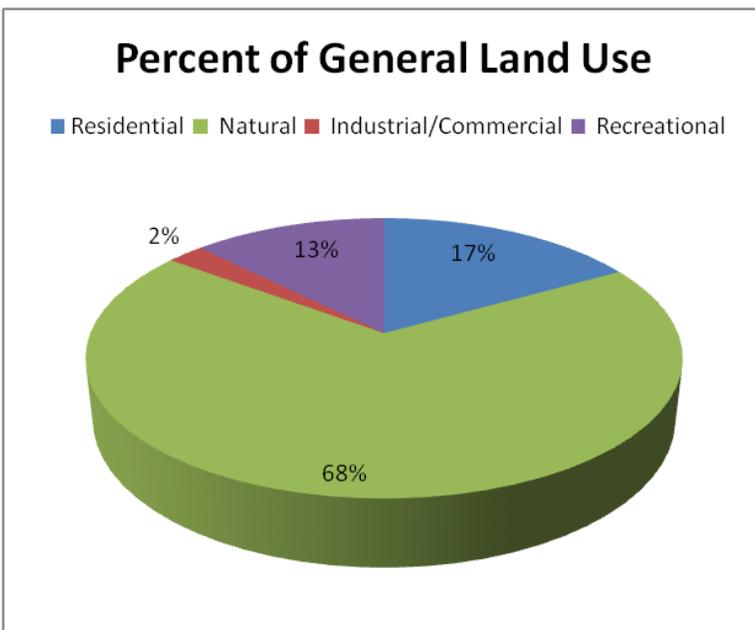
Chart 2: General Land Use Adjacent to Poole Creek

The macro stream assessment protocol divided the General Land Use criteria into nine different categories adjacent to Poole Creek. The assessment found 68 percent of the land use adjacent to Poole Creek to be natural, which is excellent considering the creek’s urban location. The majority of the natural sections were found closer to the headwaters of Poole Creek as this area has been minimally developed. There are a number of wooded areas that have been maintained throughout the surrounding development along the watercourse of Poole Creek. Some of these areas are found as part of the development upstream of Stittsville Main Street to the headwaters and in the reach between Springbrook Drive and Sweetnam Drive. The other land use categories for the protocol criteria that are found adjacent to Poole Creek included residential, industrial/commercial and recreational and are outlined in Chart 2. The remaining five protocol categories (active agricultural, pasture, abandoned agricultural fields and other) were not apparent in the Poole Creek Watershed at the time of the assessment’s completion.

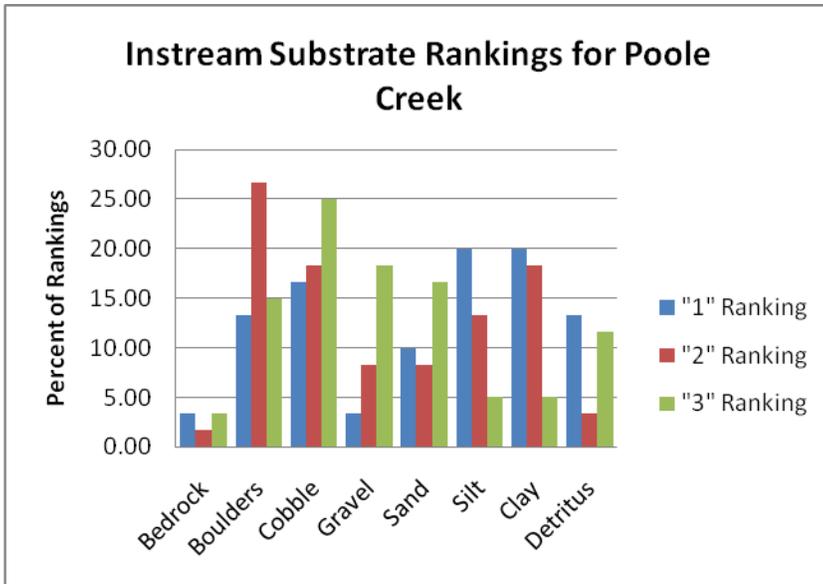
Chart 3: Instream Substrate Rankings for Poole Creek

Poole Creek contains various kinds of substrate throughout the watershed. This assessment looked at nine different substrate types and ranked them from 1 to 3 based on their dominance in each section with a ranking of 1 being the most dominant and 3 being the least dominant. Diverse substrate is important for fish and benthic macroinvertebrate communities because some of the species can only live in certain types of substrate and some species require certain types of substrate for reproduction. Therefore complex variations in the substrate allows for a more diverse fish and benthic community by providing the necessary habitats for these species; which in return allows for an overall healthier and more resilient stream.

As Chart 3 outlines, the diversity in the amount of different substrate types is exceptionally good. With Poole Creek being a free flowing cool/cold water stream, the dominance of the boulders and cobble substrate is typical. Boulders and cobble provide needed shelter for fish species and also provides essential habitat for benthic species such as caddisflies, stoneflies and mayflies. The gravel substrate was also fairly abundant throughout the creek, and is a very important substrate as it provides critical nursery habitat for fish species found within Poole Creek.

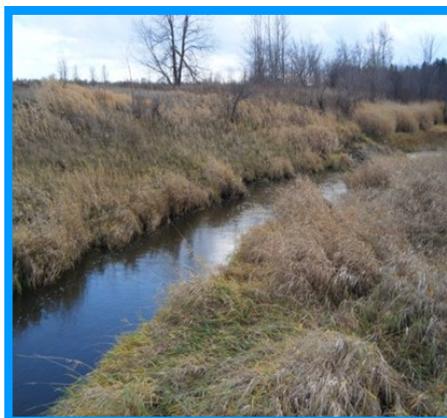
Poole Creek was found to have boulders through almost half of its watercourse. A large number of the boulders

within the stream were located in the more free flowing stretches that are found in the sections of Poole Creek located near its headwaters by West Ridge Drive to Stittsville Main Street and from Sweetnam Drive to Hazeldean Road.

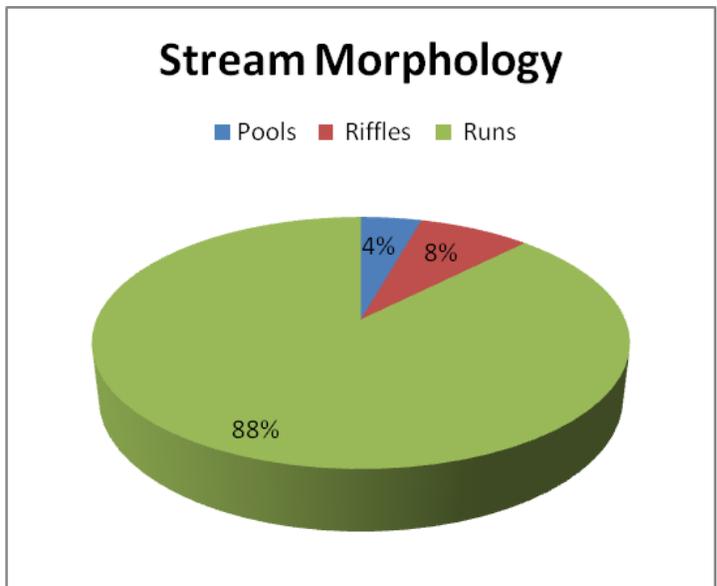
Chart 5: Stream Morphology of Poole Creek

The morphology of Poole Creek was characterized the same way as the previous assessment categories have been evaluated, by estimating a percent value for the amount of each feature contained within the creek. Riffles and pools are extremely important for fish habitat. Riffles are sections of moving or agitated water that provide dissolved oxygen for the stream. Riffles also provide spawning habitat for some species of fish such as brown trout that are found within Poole Creek as they like to spawn in shallow, gravelly, well oxygenated waters. Pools provide shelter for fish species and with pools being generally deeper than riffles, they provide refuge for fish species in the summer months when water levels tend to drop and water temperatures increase. Runs in a creek tend to be noted as the moderately shallow areas that have unagitated surfaces of water. The deepest part of the channel (known as the thalweg) usually is located in the center of the channel in run areas of a creek. Poole Creek was assessed as being almost completely composed of run morphology, with 88 percent of the overall creek length being considered runs. Riffles and pools made up the rest of morphology characteristics at 8 and 4 percent, respectively, of the entire length of Poole Creek.

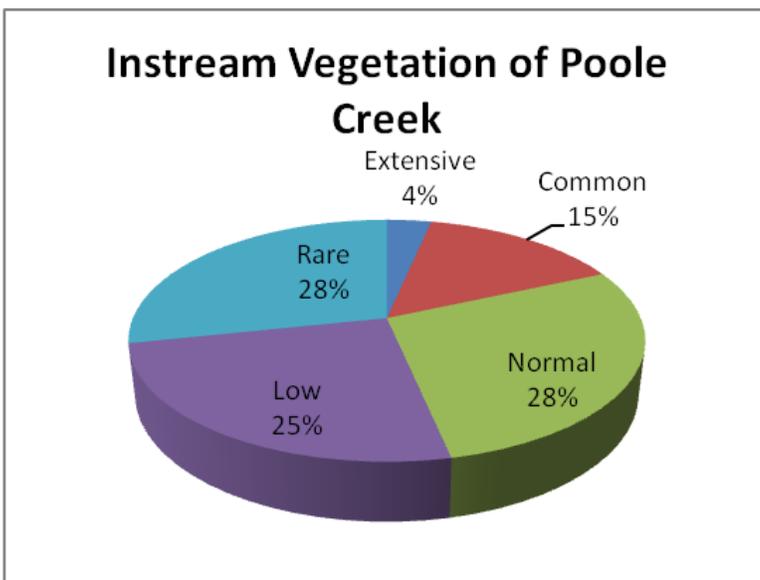
Chart 6: Instream Vegetation of Poole Creek

Instream vegetation for Poole creek was categorized in 5 different categories. These categories classified the instream vegetation as being extensive (choked with weeds), common (more than 50% vegetation), normal (25-50% vegetation), low (less than 25% vegetation) and rare (instream plants are scarce). The assessment categorized the instream vegetation as being normal and rare category for 28 percent of the creek and low for 25 percent of the creek.

The remainder of the sections sampled classified instream vegetation as being common for 15 percent and extensive for 4 percent of Poole Creek. A moderate amount of instream vegetation is important because it

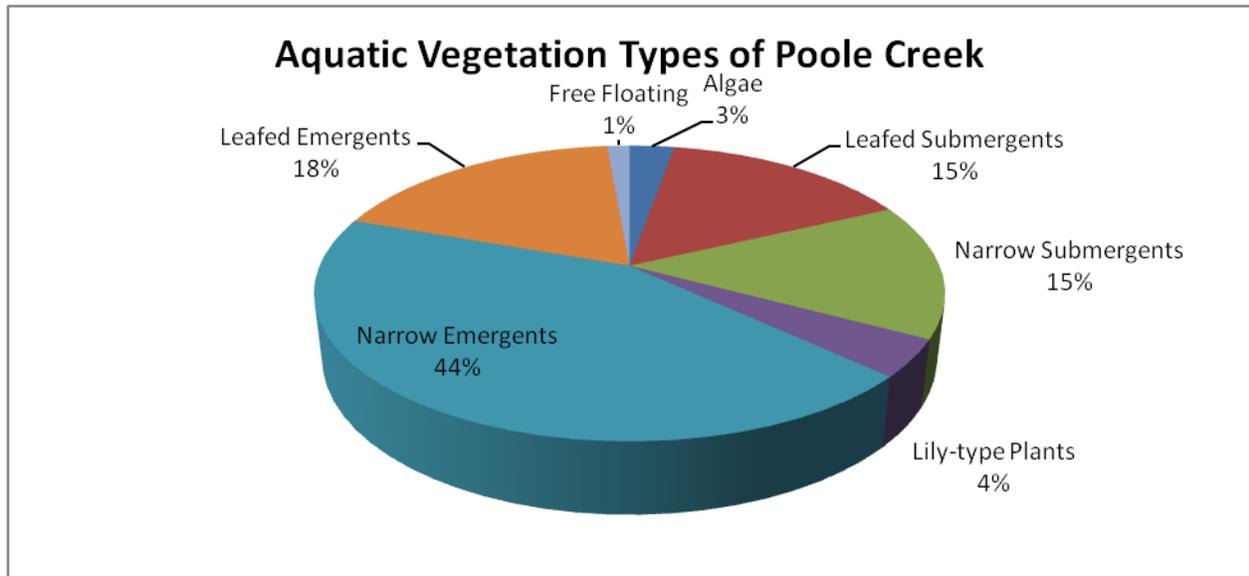
Chart 7: Aquatic Vegetation Types of Poole Creek

The types of aquatic vegetation were categorized into seven different vegetation categories. These categories were algae, leafed and narrow submergents, lily-type plants, narrow and leafed emergents, and free floating vegetation. As seen in Chart 7, narrow emergent vegetation was the most dominant of all vegetation types found in the sections

sampled with a value of 44 percent. Leafed emergent vegetation was next with 18 percent, narrow and leafed submergents both had values of 15 percent and lily-type plants were found in 4 percent of the sections sampled. Algae and free floating vegetation made up the remainder of Poole Creek’s vegetation at 3 and 1 percent respectively.

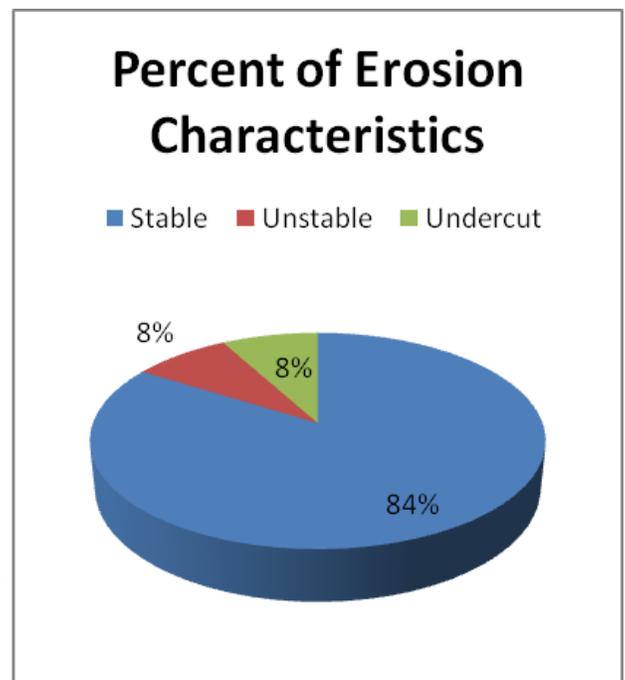
Chart 8: Percent of Erosion Characteristics

The banks of Poole Creek for the majority were found to be stable with 84 percent of the banks having little or no erosion. The categories of unstable and undercut banks were tied at 8 percent a piece. The majority of Poole Creek banks are considered to be of a low slope, leading to generally more stable banks. If the banks tend to be of steeper grade there is a significant amount of pressure put upon the banks when there is a significant rise in both the water level and flow, which leads to bank erosion. If the banks are of a lower grade, there is not as much resistance when water levels and flows increase, therefore there is less bank erosion occurring, which leads to more stable banks. The bank slope of both the right and left banks was looked at more in depth to categorize the severity of the bank slope in each section. The categories evaluated the banks as being either very steep (>25%), steep (16-25%), moderate (9-15%), low (4-8%) and broad flat banks. As mentioned above, the majority of Poole Creek banks were considered to be low slope. Of the sections sampled, 31.67 percent of the left bank and 30 percent of the right bank were in the low bank slope category. Moderate and broad flat banks made up the next two biggest values and a minimal amount of the sections sampled were considered to have steep or very steep banks.

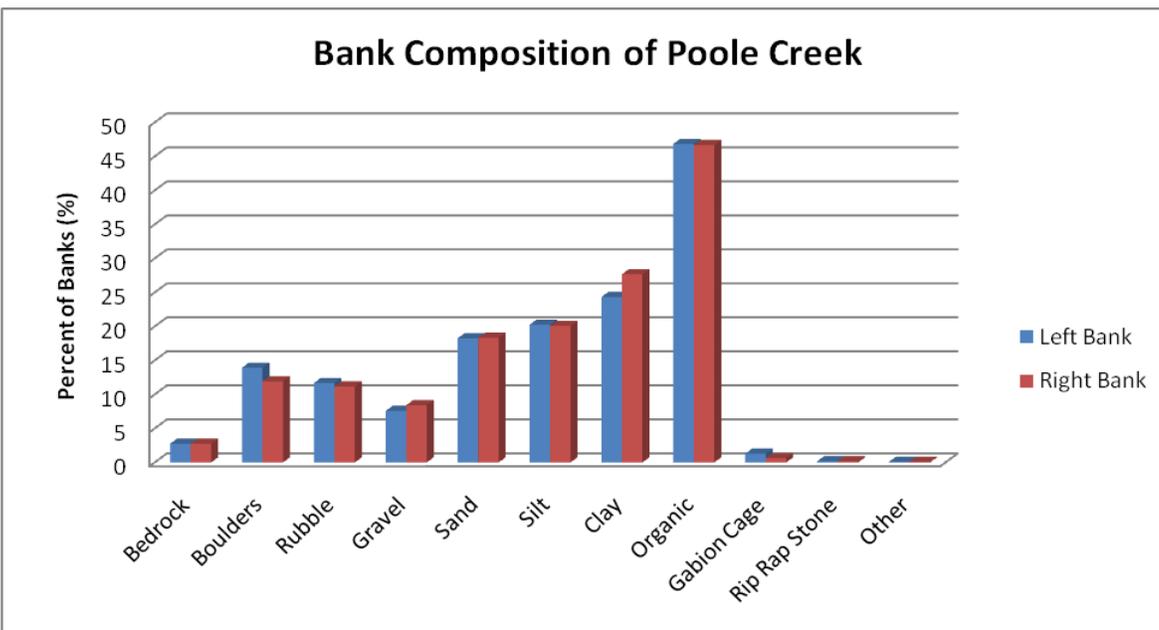
Chart 10: Bank Composition of Poole Creek

The composition of the left and the right banks were looked at to evaluate the materials that the banks were composed of and the materials potential to create future erosion. The composition of both the left and right banks seemed to be almost identical to one another with organic material being the most abundant of all bank materials at 46.83 and 46.67 percent, respectively, of all the sections sampled. Clay (18.25, 18.33), silt (20.25, 20.08) and sand (24.33, 27.67) were the other three major types of bank materials to make up Poole Creek's bank composition. The high amount of organic material composing Poole Creek's banks shows that there is a significant amount of root base from vegetation holding the banks together, which as outlined previously, leads to generally more stable banks. Clay type soil consists of very fine particles that have a tendency to bind together, therefore making for even greater bank stability and resistance to erosion.

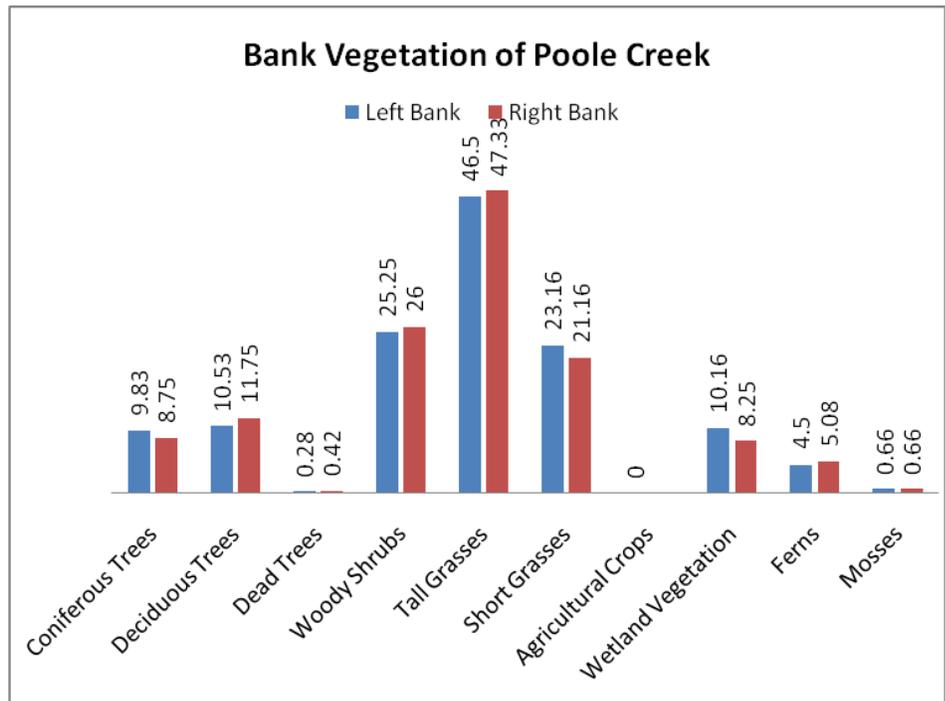
Chart 11: Bank Vegetation of Poole Creek

vegetation, ferns and mosses (Chart 11). Tall grass species was the most noted vegetation type found along the banks of Poole Creek with values of 46.5 percent for the left bank and 47.33 percent for the right bank of all sections sampled.

The bank vegetation along Poole Creek was also evaluated to assess the different types of plant communities that inhabit Poole Creek. Riparian vegetation along a stream is very important in preventing bank erosion as the roots dramatically increase the stability of the stream banks by holding soil particles together. Vegetation whose roots have a greater tensile strength makes for increased bank stability. The increased tensile strength holds soil particles together more efficiently which enhances the prevention of bank erosion. This assessment looked at ten different vegetation communities which included coniferous tree, deciduous tree, dead trees, woody shrubs, tall and short grasses, agricultural crops, wetland vegetation, ferns and mosses (Chart 11). Tall grass species was the most noted vegetation type found along the banks of Poole Creek with values of 46.5 percent for the left bank and 47.33 percent for the right bank of all sections sampled.

Short grass and woody shrubs were the next most abundant vegetation types with values ranging from 21 to 26 percent of all sections sampled. Wetland vegetation species were present along the creek but as the above chart outlines not to a great extent. This result is mainly because the areas where the majority of the wetland vegetation species were present were non-navigable. Most wetland areas were unable to be evaluated during the assessment, leading to a reduced percentage of wetland vegetation species in the sections sampled.

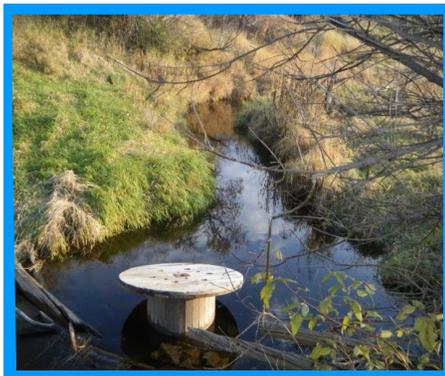
Pollution and garbage within Poole Creek was very substantial and apparent in certain areas. Given Poole Creek's urban location, the potential for residential

waste entering the creek is fairly high. There were a lot of building materials (ie. Lumber, wood pallets, concrete blocks, etc.) found within the creek, some of which had created "dams" in certain areas gathering debris and impeding natural flow. There was also a lot of other residential waste found within the creek which included bicycles, glass and plastic bottles, road signs, shopping carts and tires. There were minimal amounts of oil or gas trails noticed in the water of Poole Creek. Overall, the amount of garbage within Poole Creek can be a cause for concern as it can negatively affect fish and wildlife habitat and also the quality of the water.
