**Kizell Wetlands, Beaver Pond Wetlands and Beaver Pond
Issues and Stormwater Infrastructure Review**

Faith Blacquiere
2 Aug 2010

Kizell Wetlands, Beaver Pond Wetlands and Beaver Pond Issues and Stormwater Infrastructure

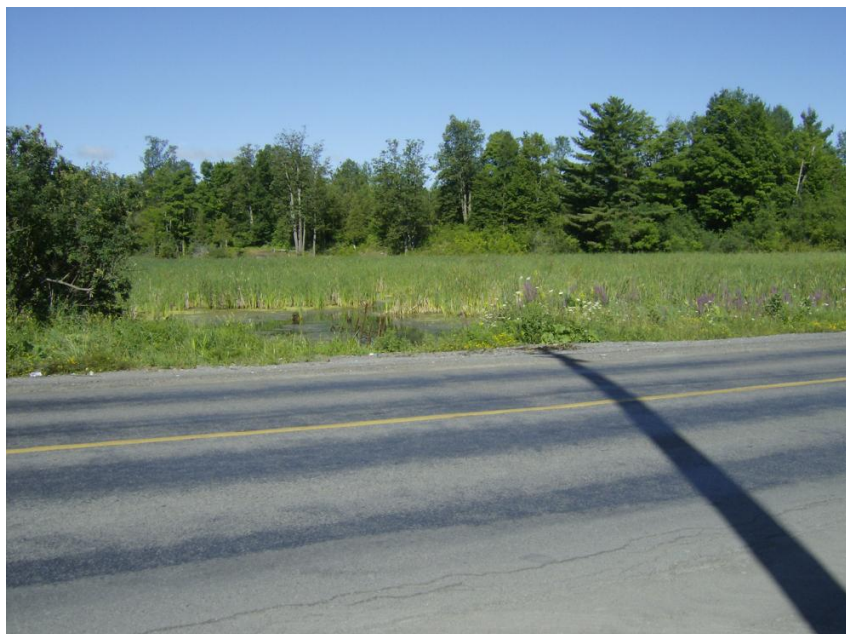
This photo shows the 29 July 2010 amount of open water in the Kizell Wetlands

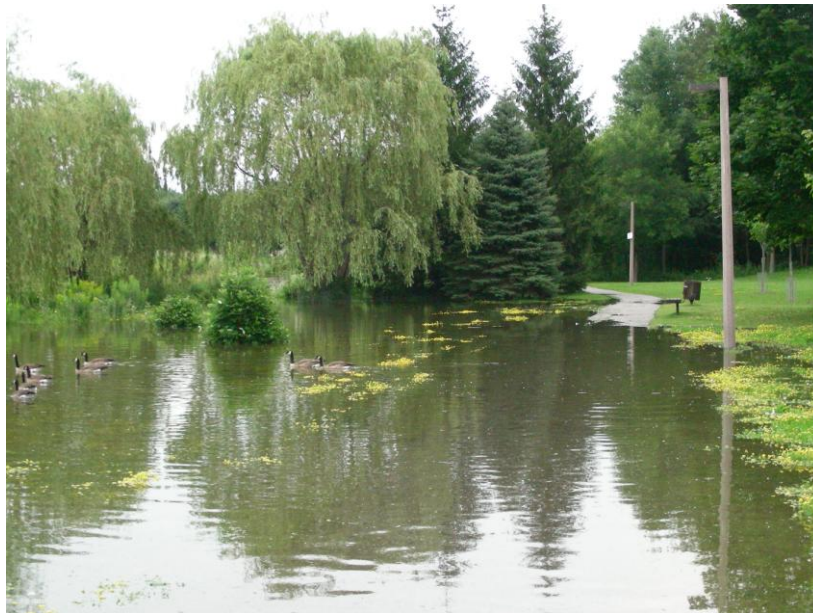
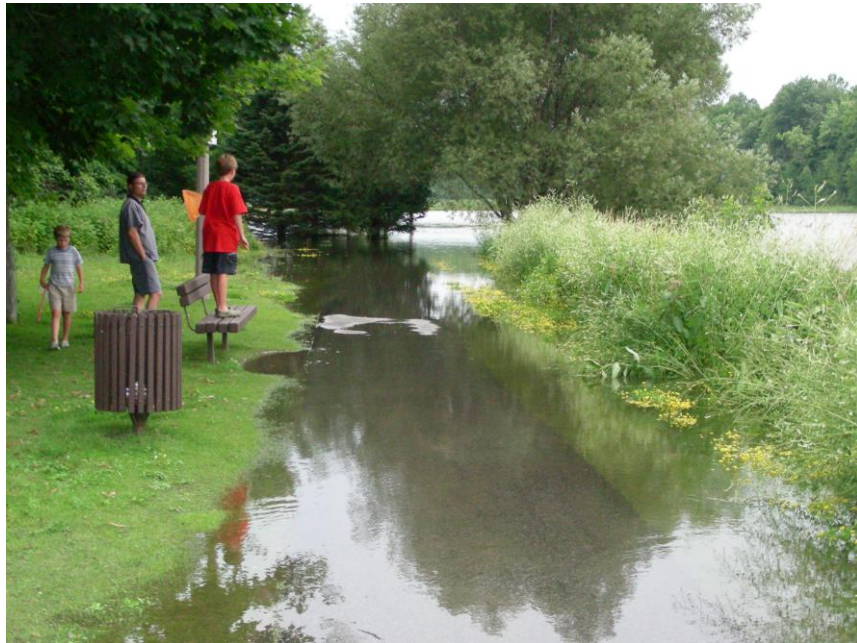
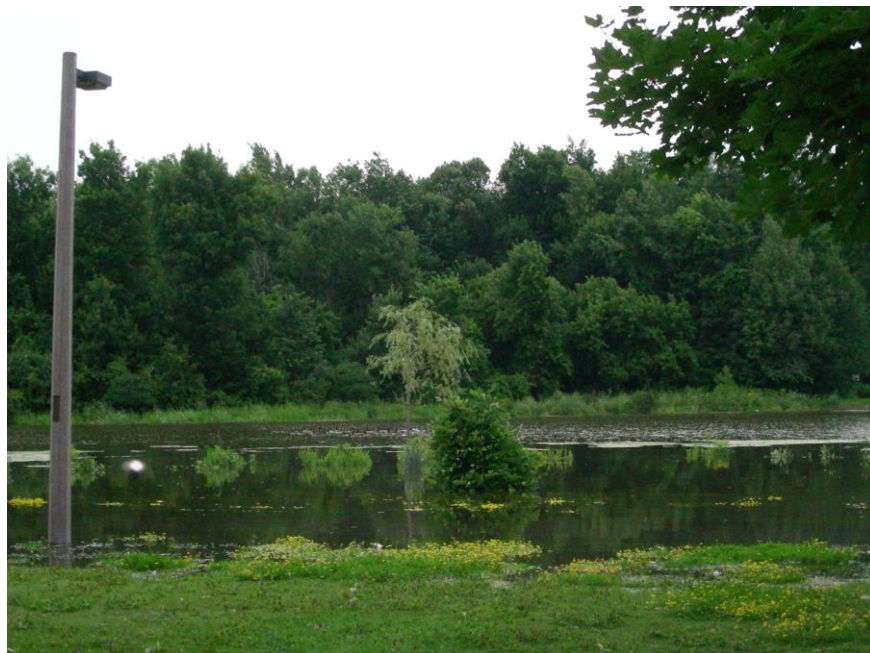
The photos are dated 25 July 2009 from 2:18 to 2:20 pm, **the day after the storm** which occurred between 4:30 and 7 pm on the 24th July.

Whether the Beaver Pond was designed to handle all of the development is unknown, but the fact that it flooded on the 24 July 2009, suggests that it wasn't. Either that, or sediment has raised the pond bottom.

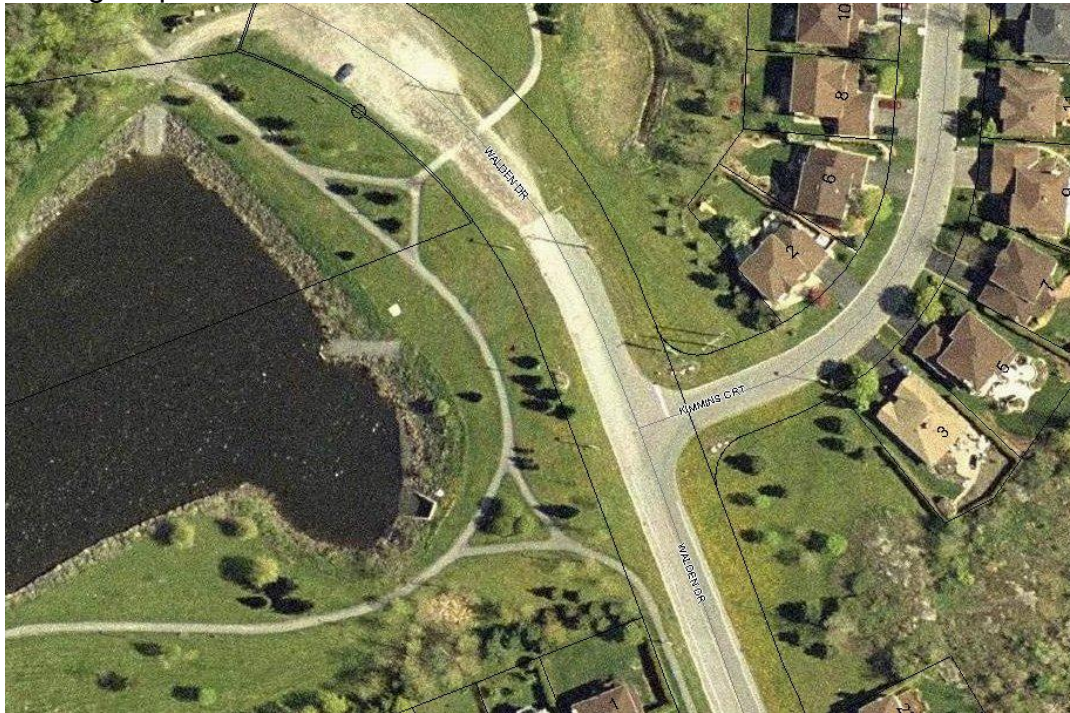
The following map from 2002 shows the Beaver Pond stormwater structures:

The Pond with a storm inlet on the south side and considerable riprap around the edges. The small white square at the east end is an access structure to a culvert which is just below the angled path at the east end. This outlet culvert goes under Walden Drive and flows to the culvert (the white rectangle at the top right, west of the second house) to Watts Creek which flows north to the railway line. It is possible that the “toe” of the Pond was created to function as a forebay, but there was no sign of a berm to separate it from the main Pond.

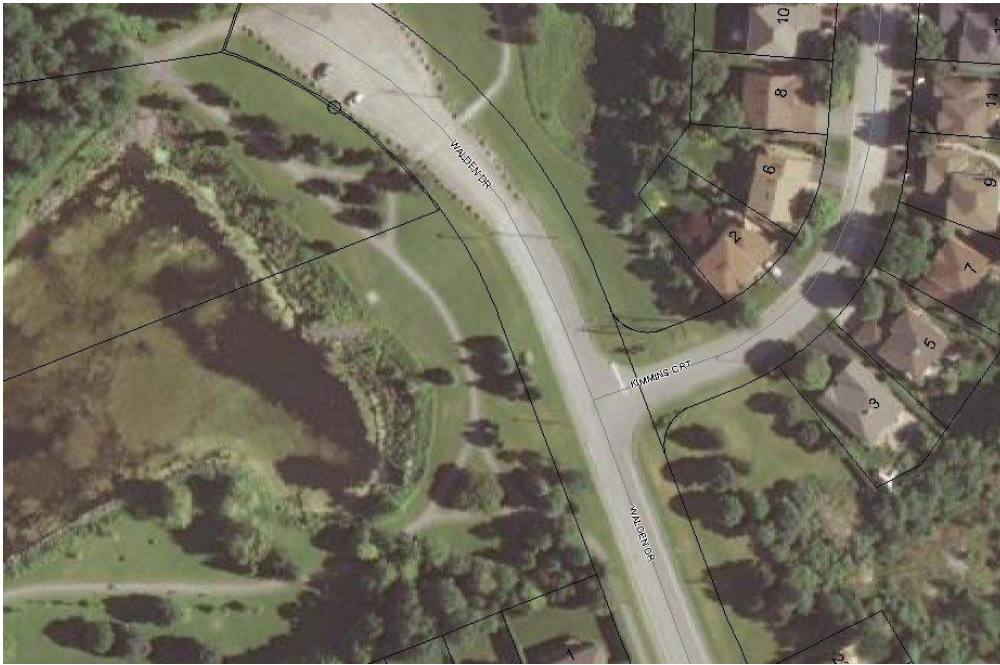
Source: City of Ottawa eMAP 2008
The 2005 and 2007 eMAPs showed the water as black

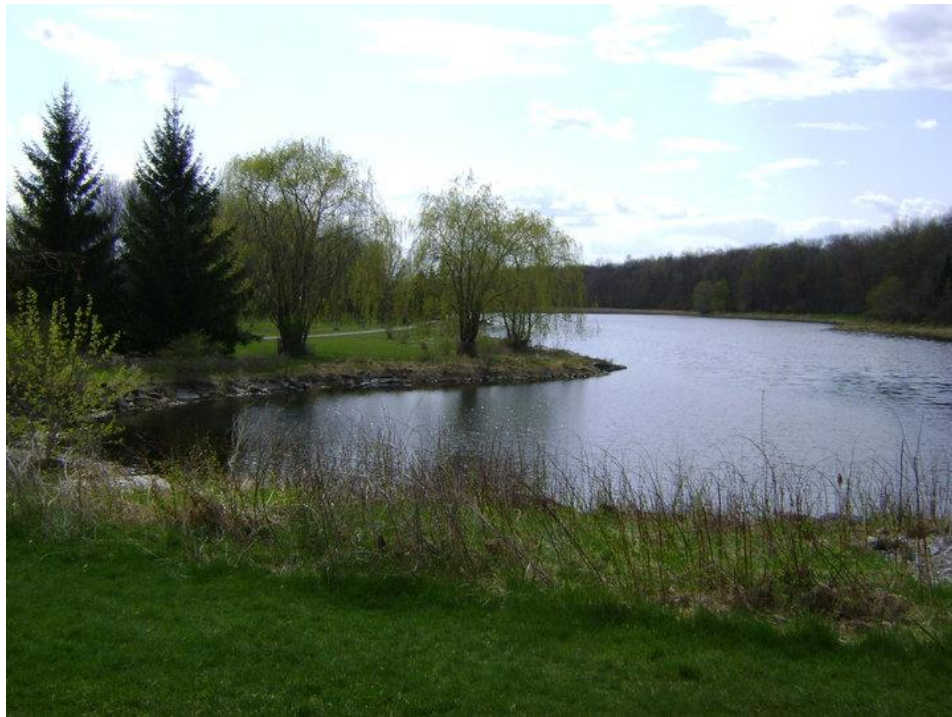
Source: Jessica Alleyn Facebook Group I Want to Save the Beaver Pond # 110
Apr 2010

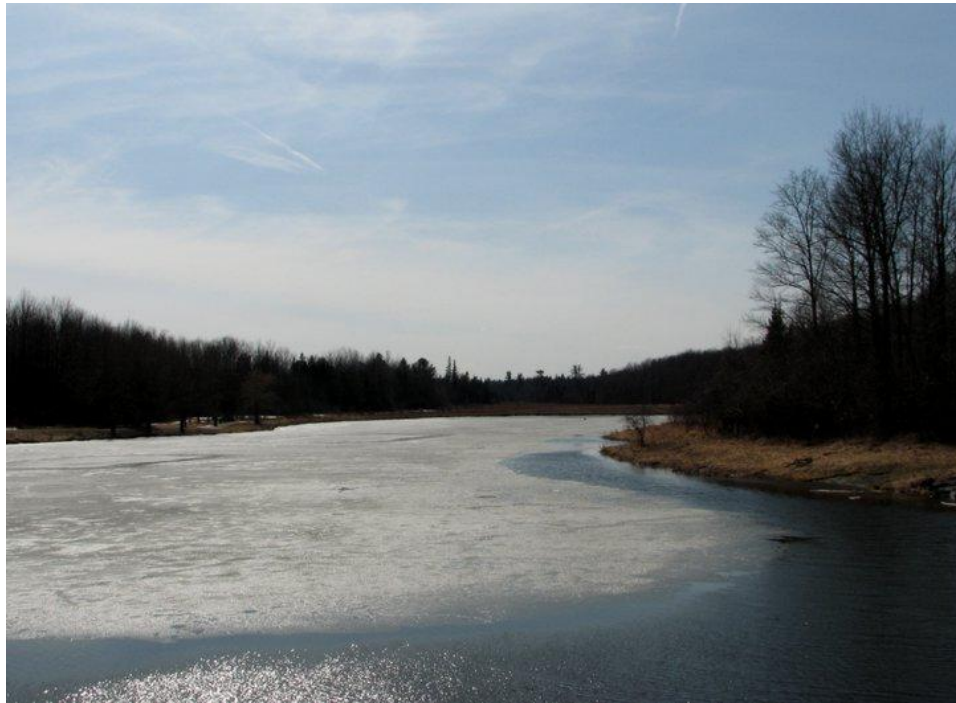
Source: Victoria Fisher Facebook Group I Want to Save the Beaver Pond # 209
Apr 2010 Water level with ice

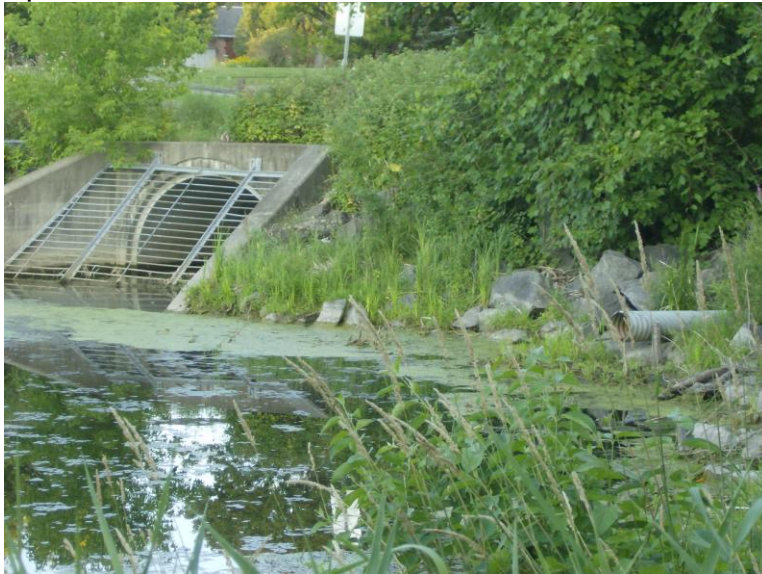
Based on the alignment with Walden Drive south, this appears to be the storm sewer inlet to the Pond. There was no flow into the Pond on 24 July 2010, and water was stagnating. The wet weather capacity is reduced due to the dry weather water level in the culvert. The small CSP culvert drains a low ponding area in the tree clump south of the pond, and goes under the pathway before entering the Pond.

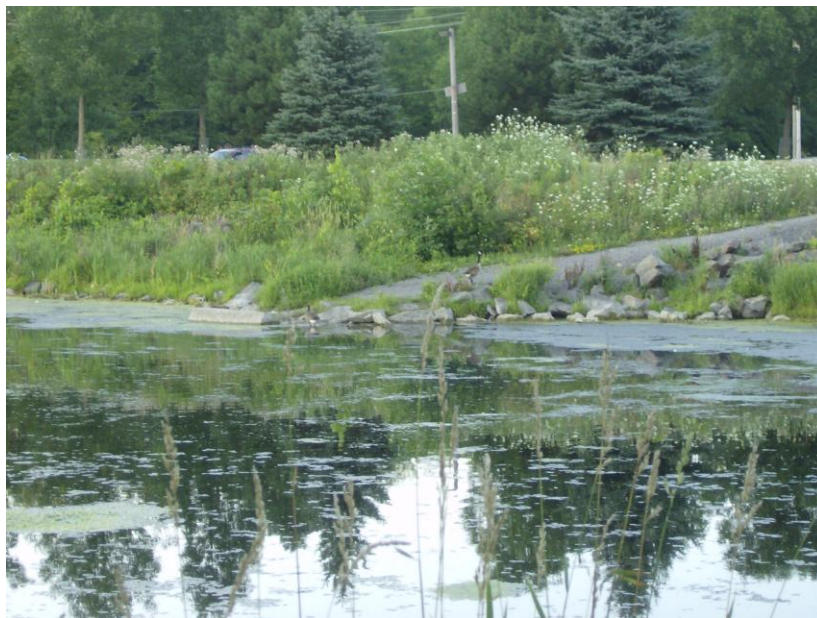
Due to its alignment with Watts Creek, this appears to be the outlet from the Pond to Watts Creek. The culvert is underground with a small portion of the concrete appearing just left of the east-end path. There is an access structure at the top of the path which is also in alignment with the Watts Creek outlet some distance east across the Walden/parking lot.

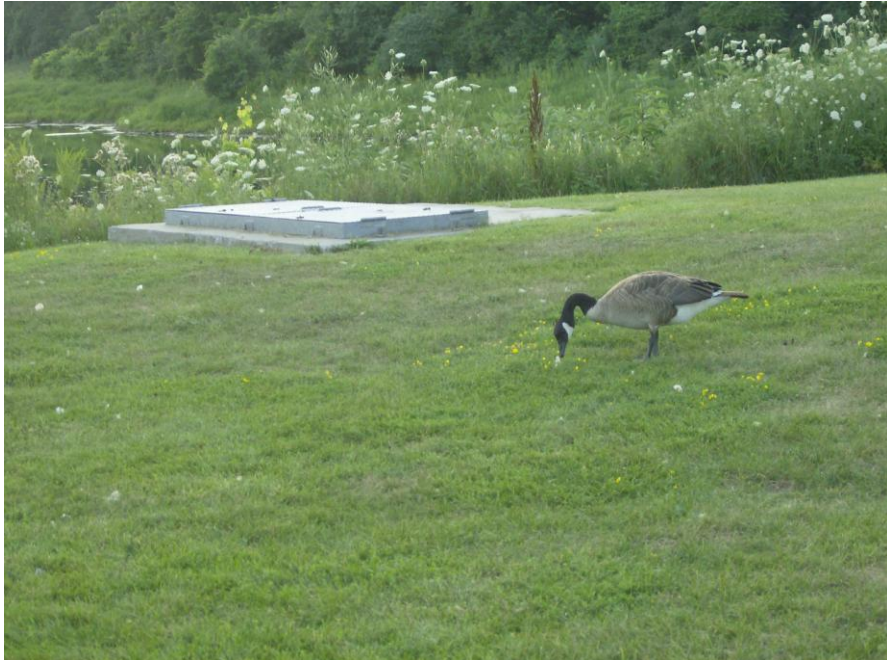
This access structure is at the top of the east-end path. There is a shallow grassed swale aligned with this towards the parking lot, which may be due to settling of the earth when the culvert was installed.

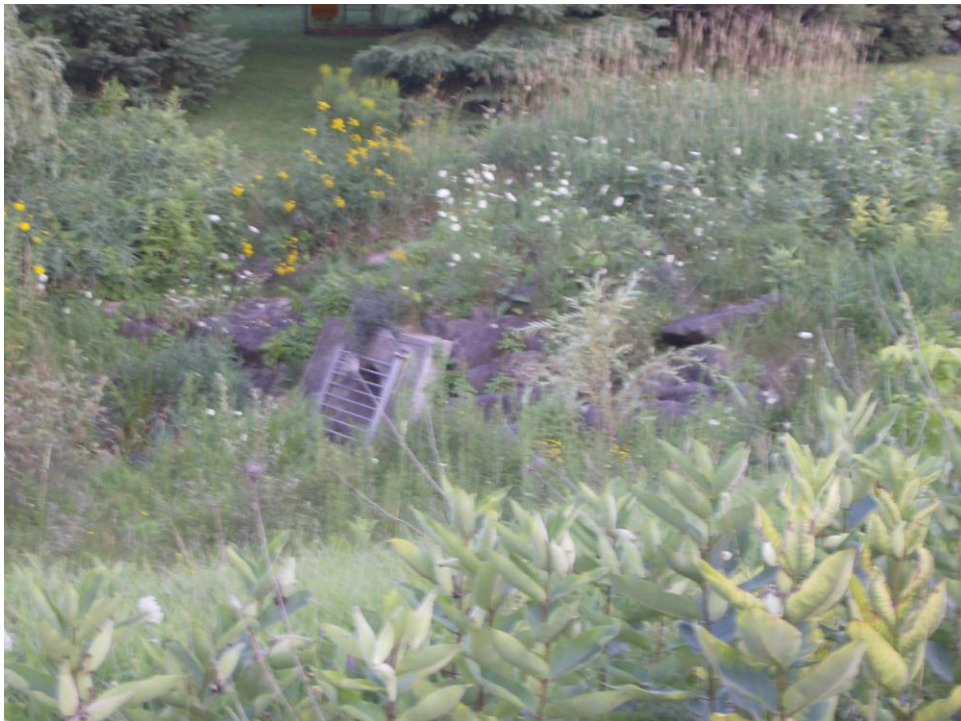
This is Beaver Pond outlet in the north Watts Creek channel

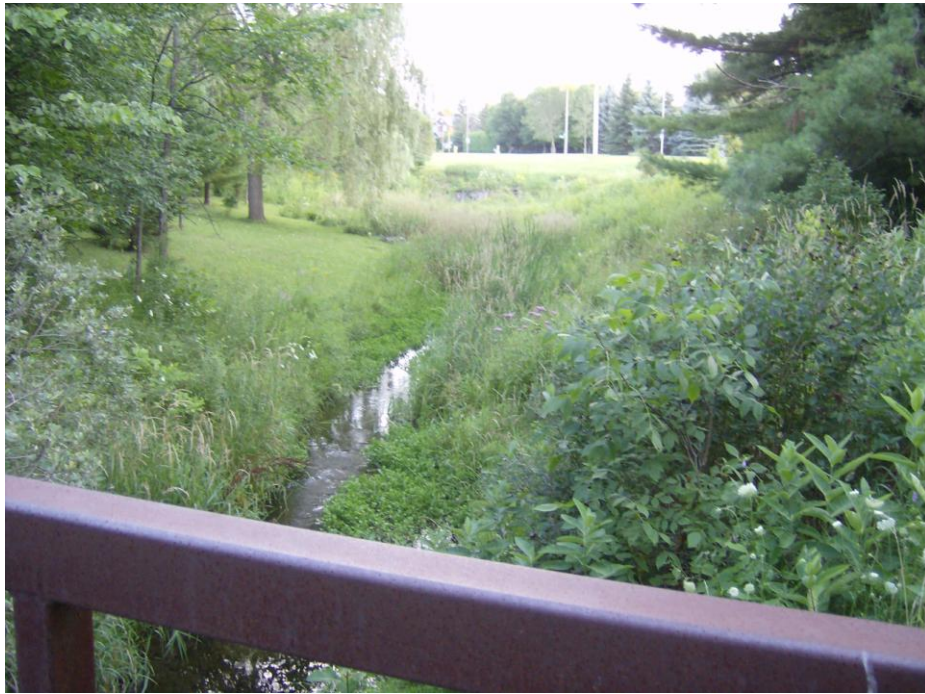
This is taken from the south side of the footbridge looking towards Walden Drive. The culvert and creek are in a depressed area and **could form a natural stormwater pond in extreme wet weather**, with the water going up onto rear yards of the adjacent Kimmins Court homes at the left.

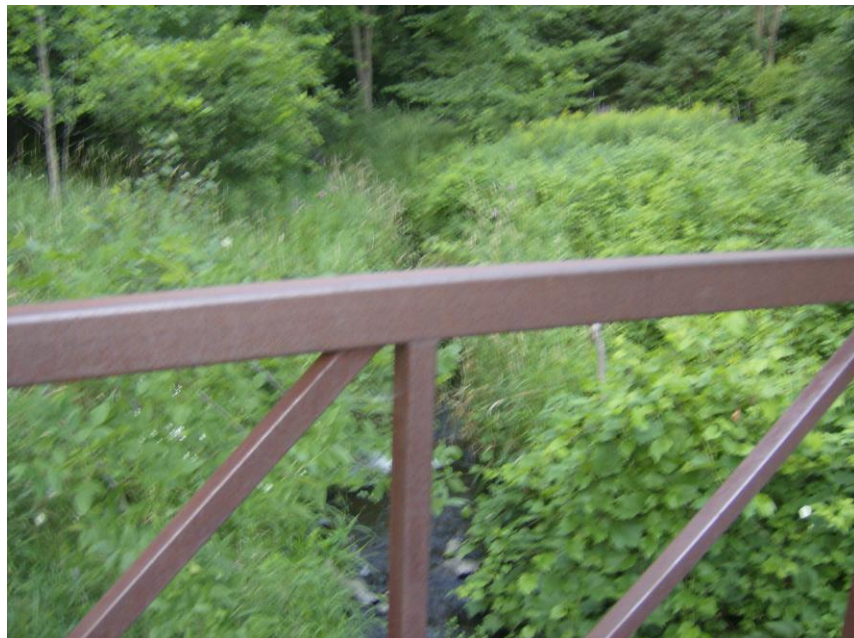
This is from the north side of the footbridge. The creek area here is also in a depressed area. This channel goes north to the railway line. KNL's Phase 9 development is shown in this KD-2 Drainage Area in the Shirley's Brook Watts Creek Subwatershed Study Sep 1999 (see map later in this document).

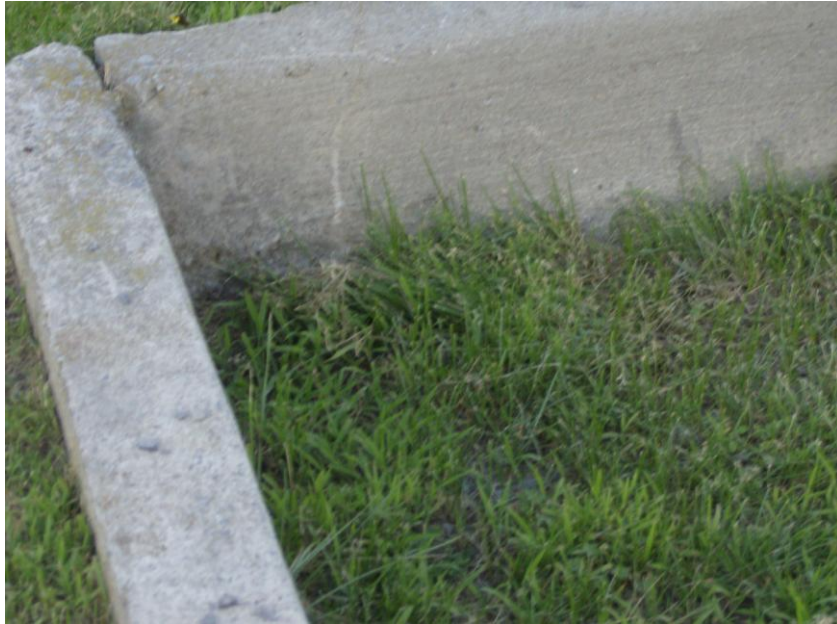
The curbs at the end of Walden where it joins the parking lot are very high and would collect overland flow coming from Walden.

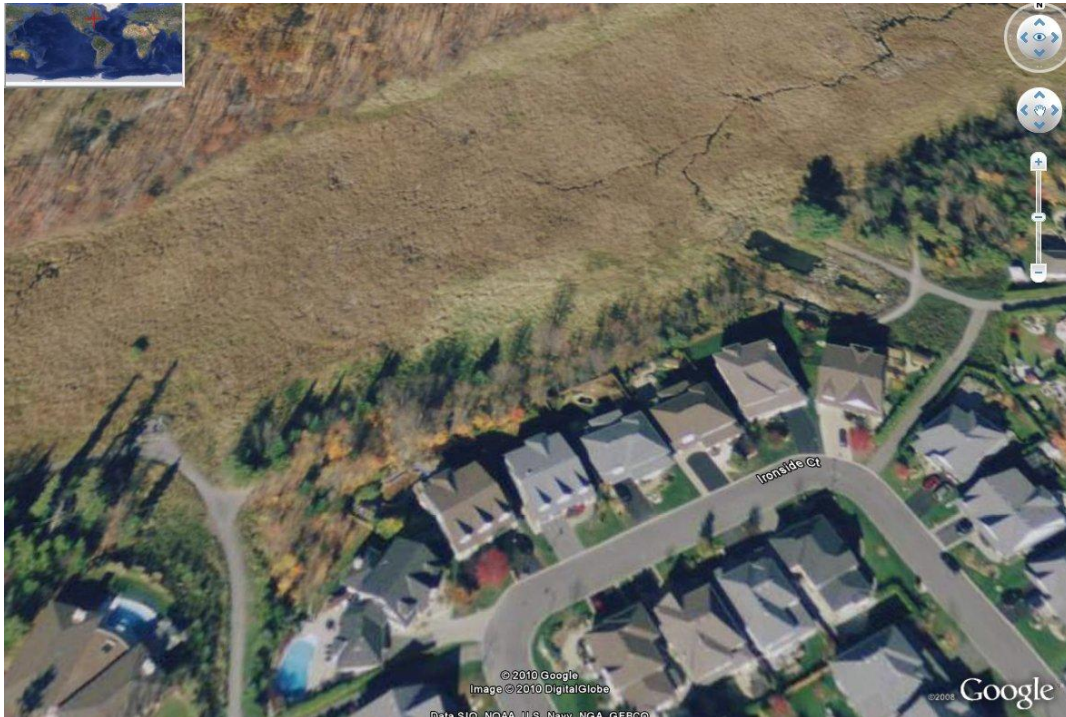
The energy dissipater is the 2 black areas at the bottom of the path at the right side. Note the flow line going out from it through the Pond. The map is from Fall 2008 Google Earth and there is water in two of the three parts of the dissipater, so it was probably taken after it had rained, but before the forebay overflowed to the third part. The path at the left leads to a raised lookout which has a bench and a sewer manhole which has no holes. It is difficult to determine whether this is a storm or sanitary sewer manhole. The path up to Charlesworth and the Charlesworth cul-de-sac have storm and sanitary sewers, but it is hard to determine which is which because they have 8 holes. The sanitary manhole covers should be replaced with fewer or no holes. Charlesworth also has a fishbone storm catchbasin at the north low end of the cul-de-sac. At the east side of the Charlesworth path there is a treed area and a dirt path running parallel, where water can be heard flowing, but no outlet to the Beaver Pond could be found.

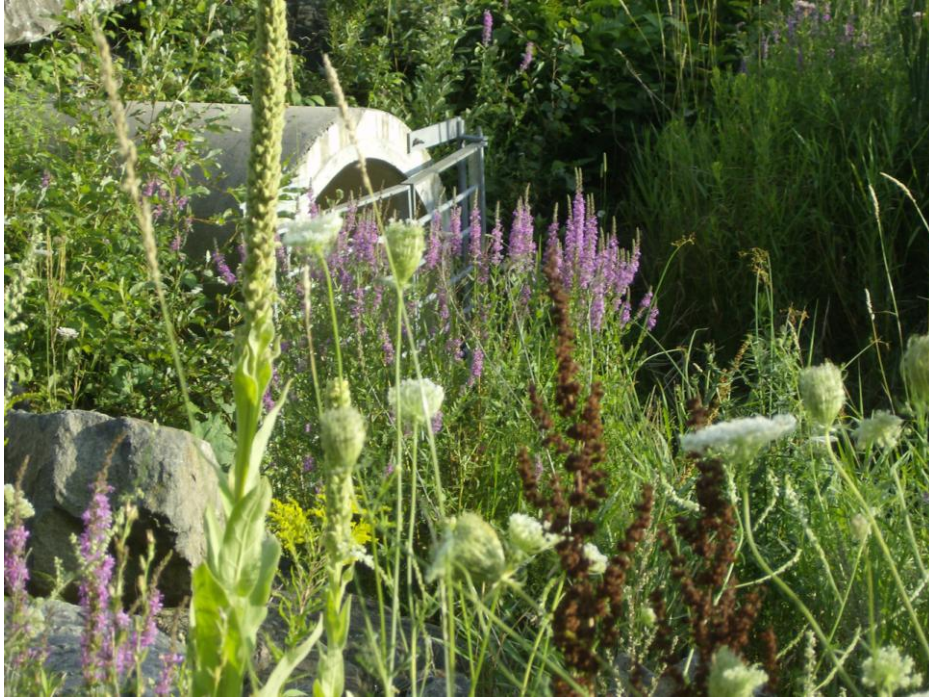
This is the main storm sewer culvert which is at the inlet to the dissipater. This culvert outlets to a small forebay.

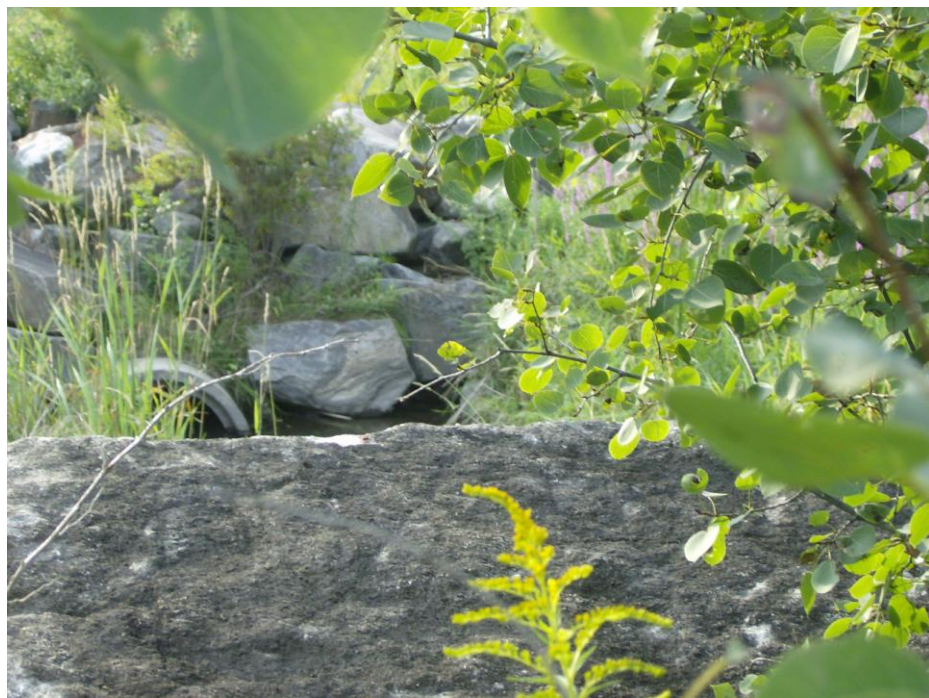
This shows the forebay outlet culvert which goes through the rock wall at the north end of the forebay, taken from the top of the forebay at the south end. Notice the water level in the culvert is very high in dry weather.

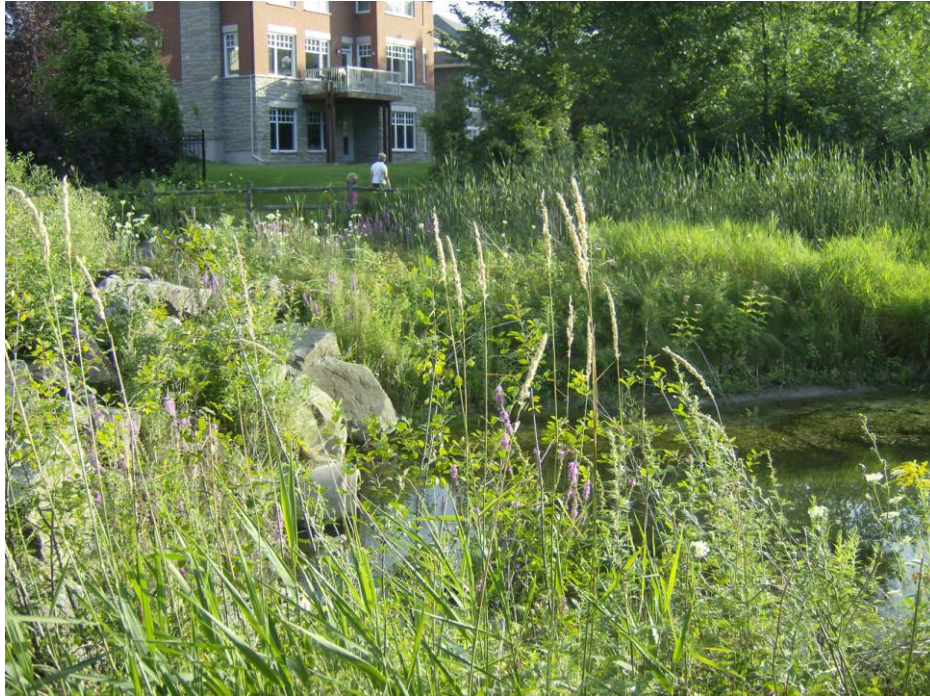
This is taken from the Beaver Pond side of the rock wall and shows the forebay outlet culvert which allows the stormwater to flow to the Beaver Pond

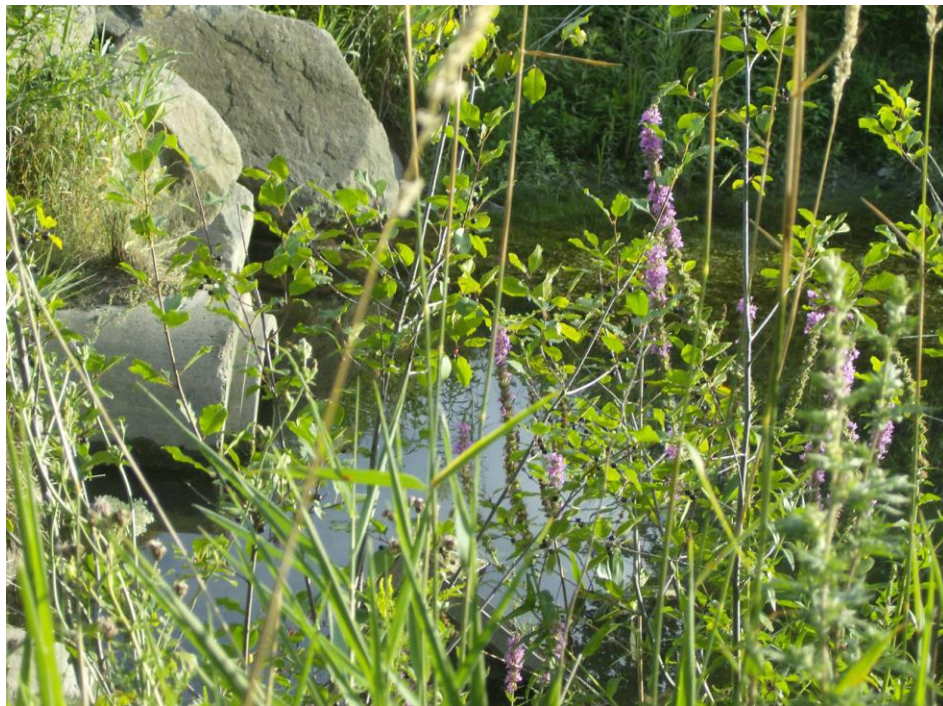
A closer view of the forebay's outlet culvert. This culvert has been built on a slope because the water level here is lower than the water level at the other end of it. Because water is in this end in dry weather, the culvert capacity is reduced.

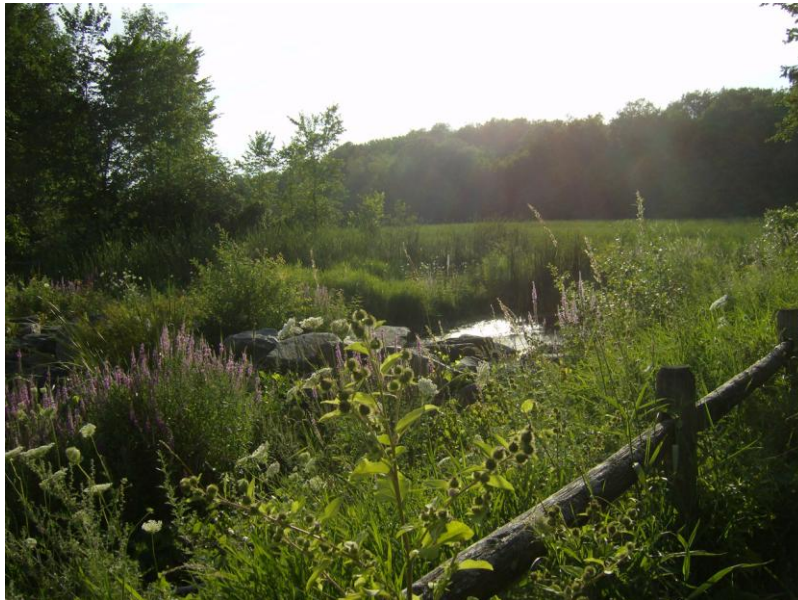
This is taken from the east side of the forebay between the main forebay culvert and the rock wall, and shows the water in the small channel which is on the Beaver Pond side of the rock wall. The water was stagnating when the photo was taken

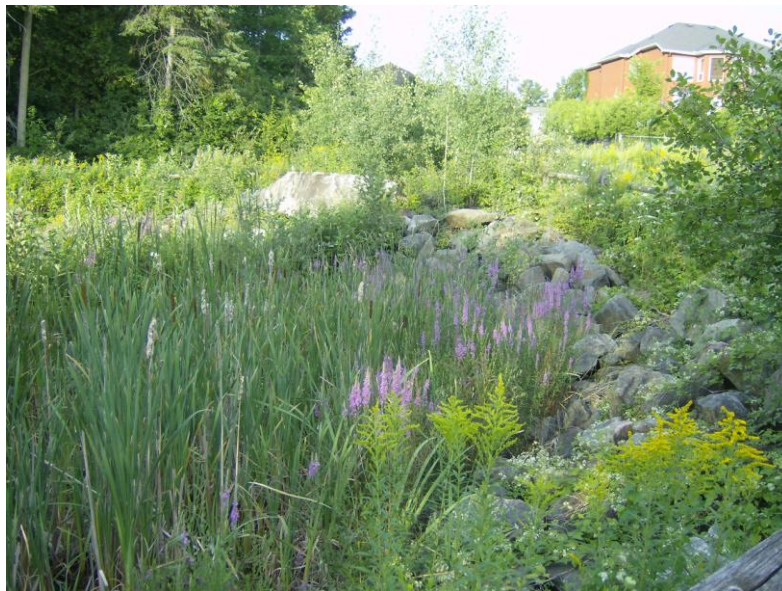
On the west side of the forebay there is an overflow area with no apparent outlet. There is a partial rock wall separating it from the forebay, where the weed line goes across in the photo. The rock wall is lower at the south end and water would spill over into it if the forebay fills too high. **If the forebay fills high enough to overflow the wall, the forebay culvert may have already been submerged, and may cause the storm sewers to surcharge.**

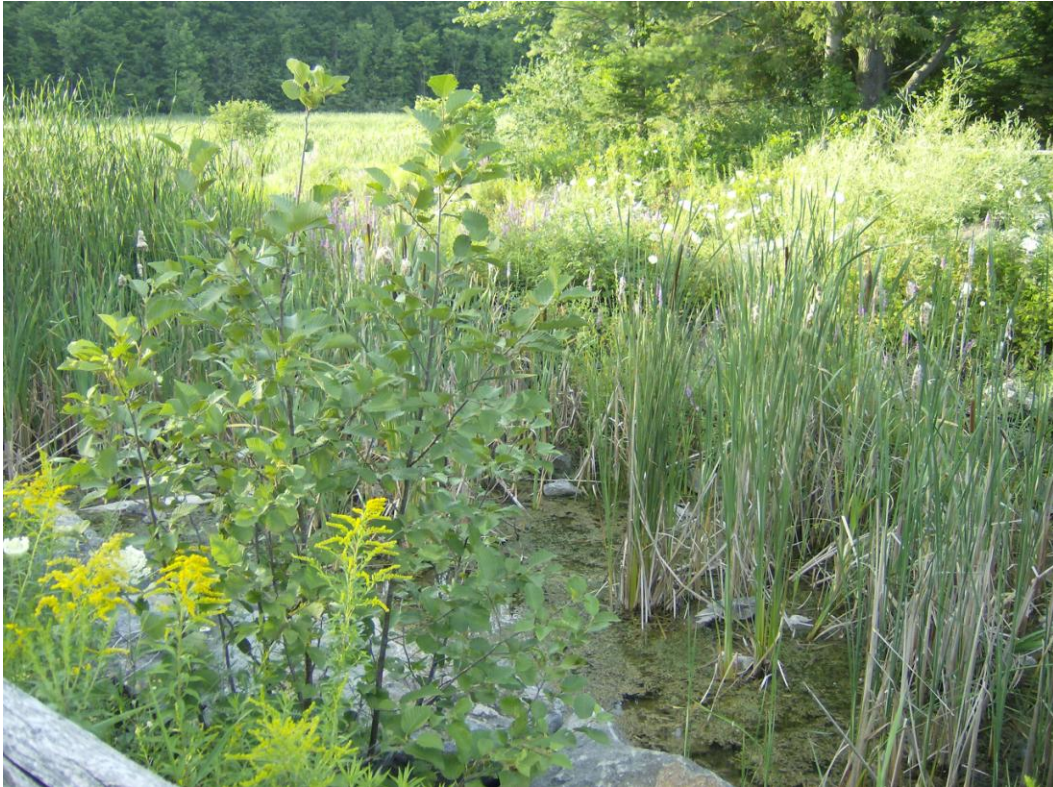
Reeds and stagnant water were in this overflow area which was very stinky in the early evening. Apparently, residents have already been having problems with odours in the area of the Pond.

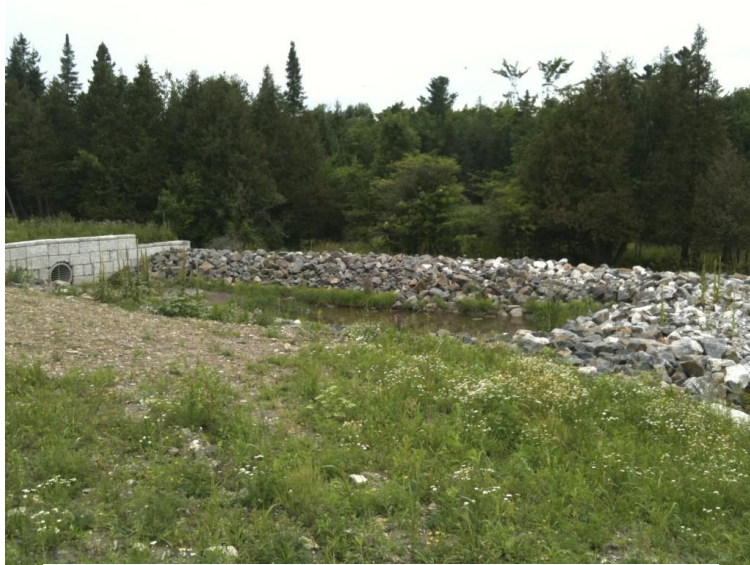
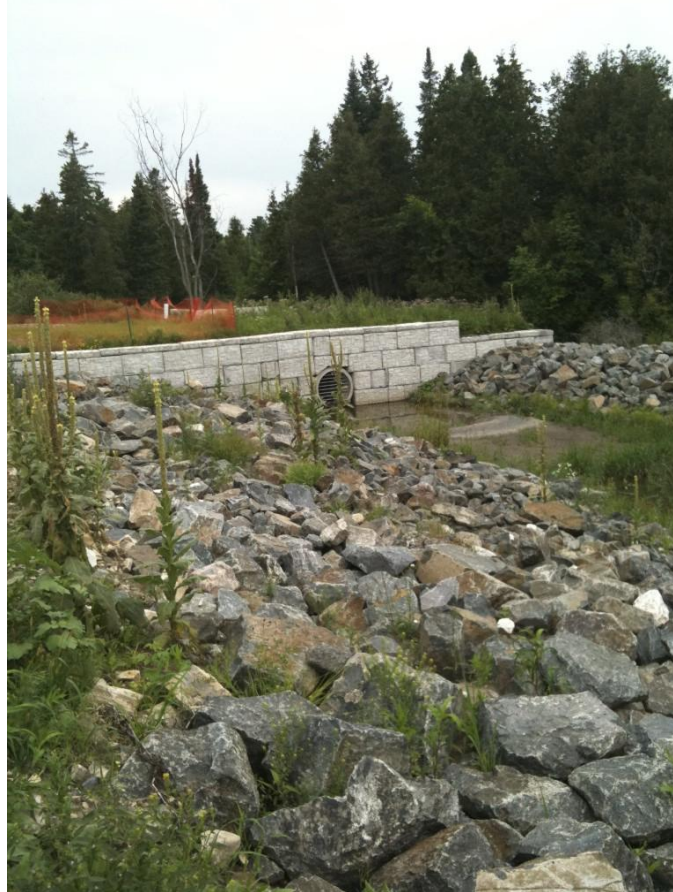
Note the sediment buildup already forming in the basin. Maintenance will be difficult due to the large riprap. It appears as if it would not take much stormwater to submerge the culvert and possibly surcharge the storm sewer. Section 4.5 Energy Dissipation Design at <http://www.georgiastormwater.com/vol2/4-5.pdf> Indicates that the outlet basins need to be deepened.

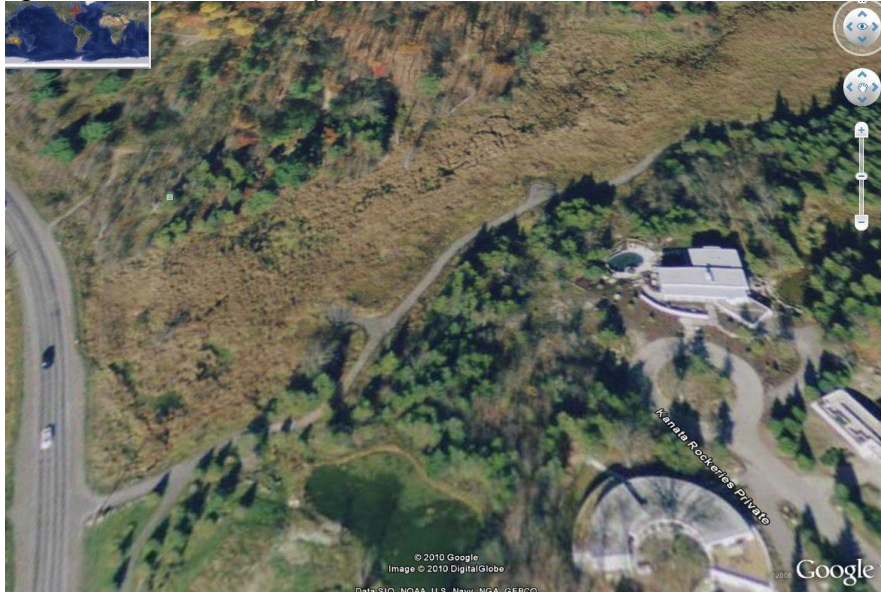
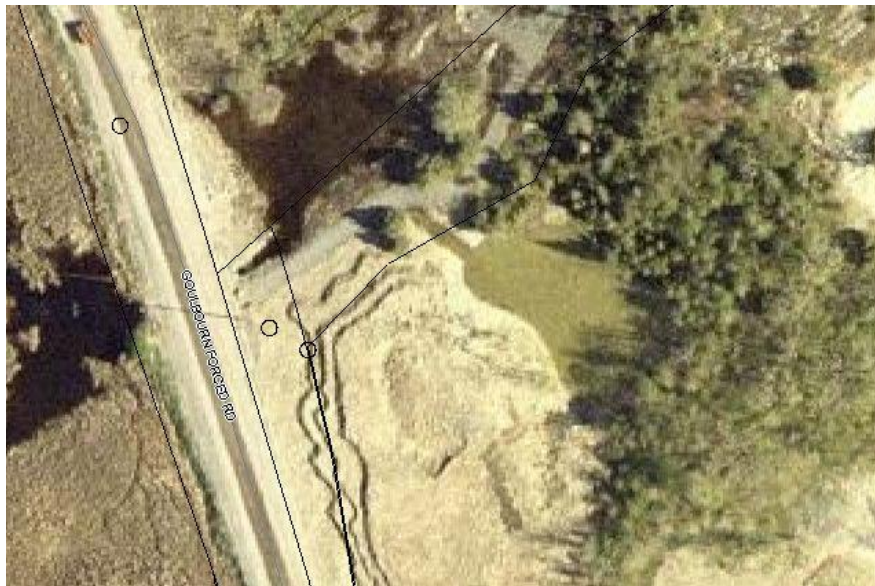
There are at least 4 private SWMPs in the Rockeries. Only one of these is visible from the pathway system. On 29 July 2010, the water level was low and stagnating. The following Google Earth and eMAP photos show some of them.

This one has what appears to be a drainage channel

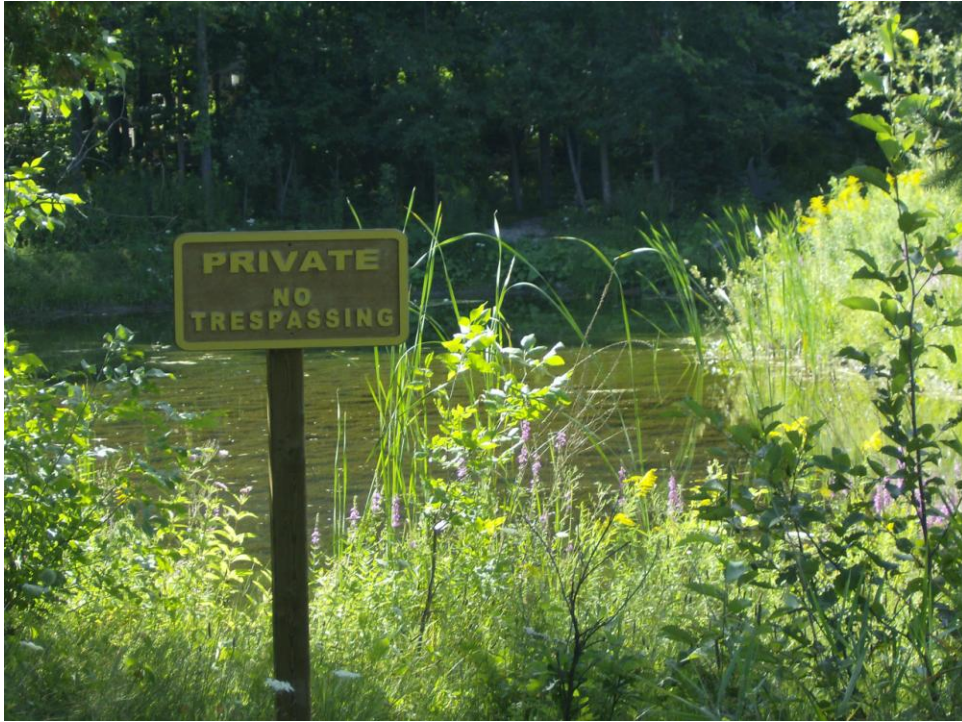
There was no apparent outlet to this pool. The only thing found was a grassed swale which had a pile of hay/grass blocking most of it.

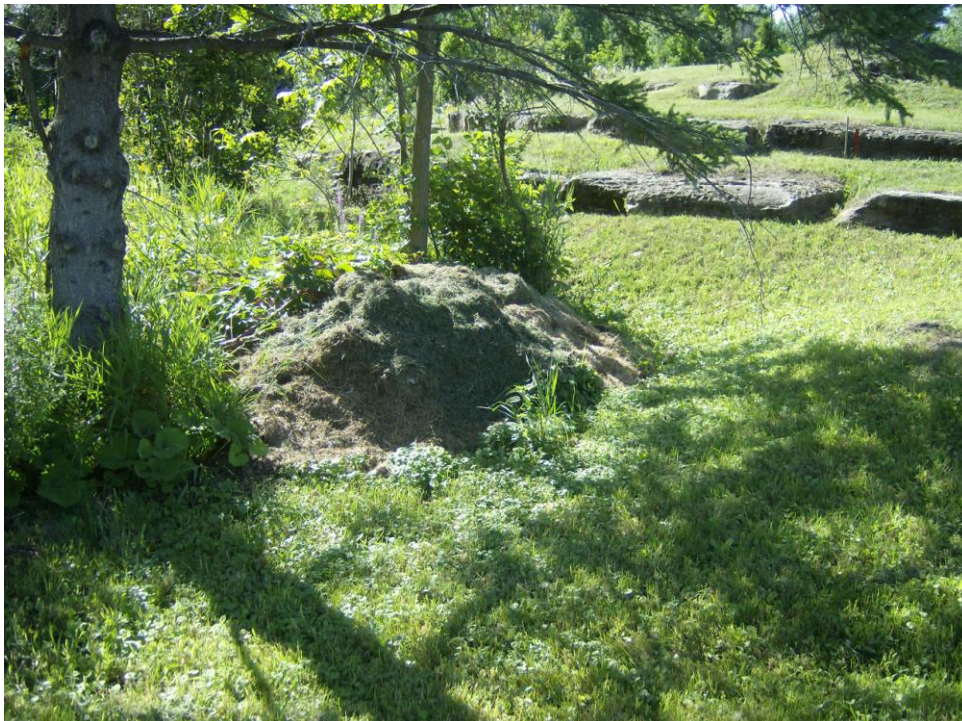
Another SWMP from eMAP – the long green area on the right side

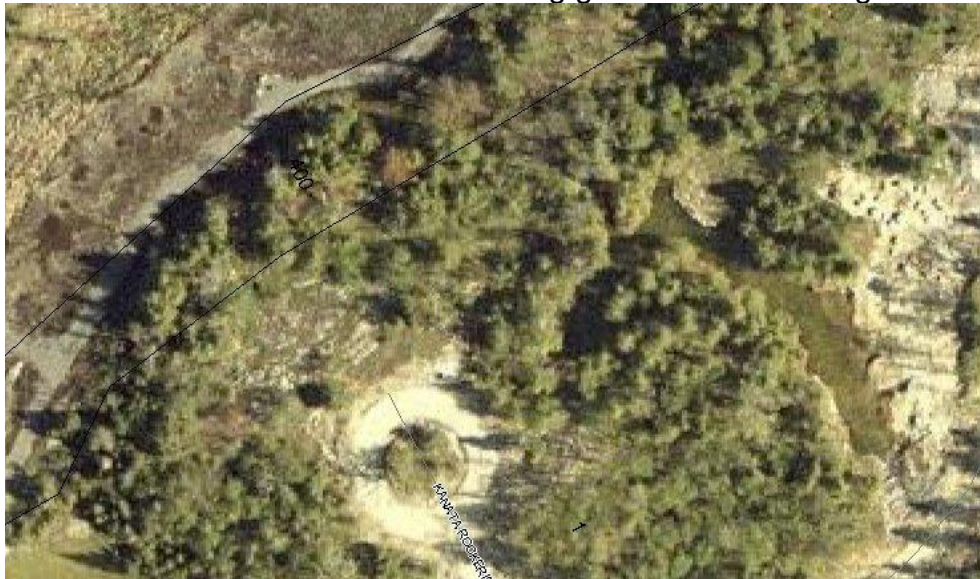
The Rockeries Parallel Channel begins just past the first cluster of old growth trees beside the pathway not far from Goulbourn Forced Road, and seems to end just past where The Rockeries property ends. This parallel channel varies in width with the widest part being about 3 feet, however, there are several pools along it where the width increases to roughly 5 to 8 feet.

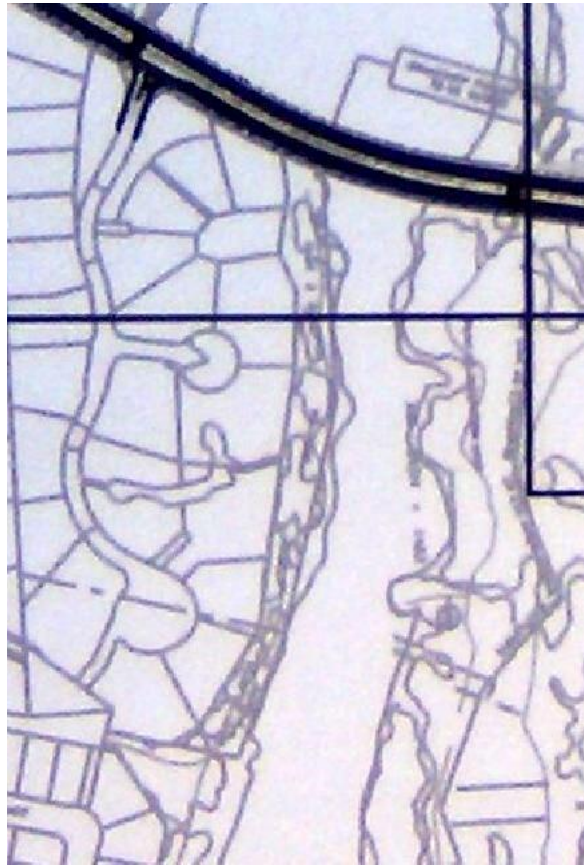
The following extract from Figure 27 Recommended Alignment Key Plan of the GFR ESR Oct 2007 shows the Rockeries. The map does not have topographical lines on the development areas. It is unclear what the lines and shapes along the Beaver Pond represent, but ponds do exist in this location.

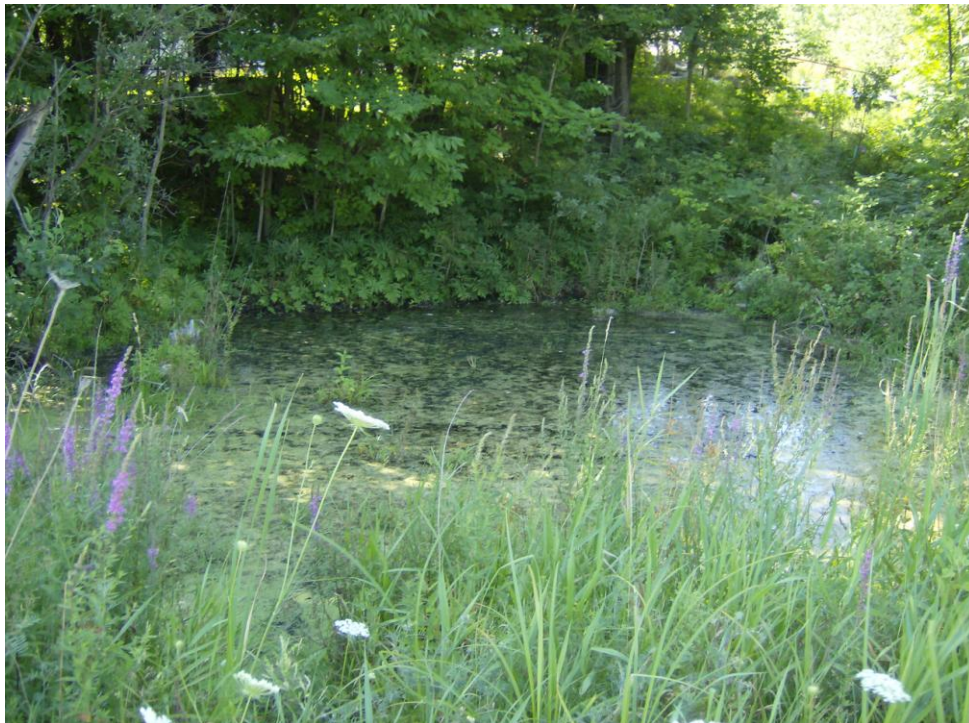
The following photo shows one of the larger pools. The water in the channel and ponds was stagnating on 29 July 2010.

One small CSP culvert (at the lower right corner) was located about mid-way which outlets under the pathway into the Beaver Pond. It is very difficult to see whether there are any more outlets to this channel due to the quantity of vegetation. A fall visit after the vegetation has decreased might reveal more.

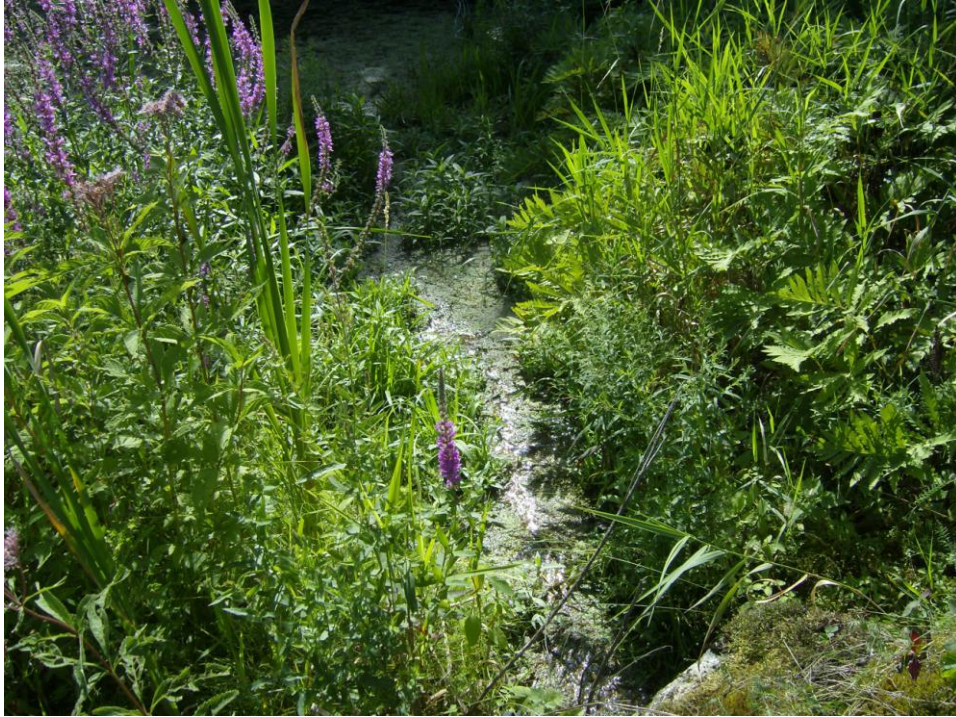
Because the pathway is fairly low most of the time, the parallel channel and pools could overflow the pathway, or the Beaver Pond could backflow to them.

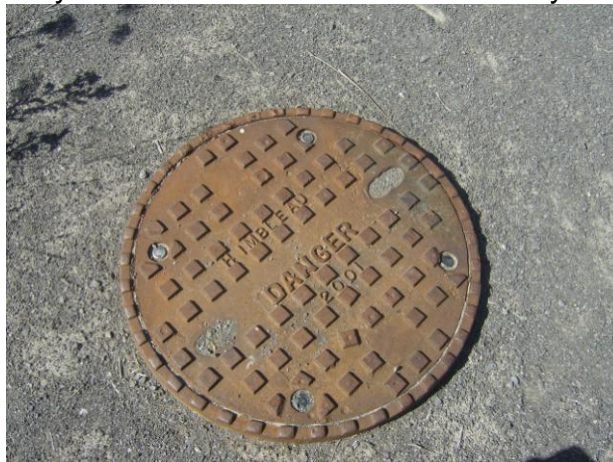
There are a number of lookouts along the south side of the Beaver Pond which have benches and sewer manholes. The sewer manholes have no-hole covers and bolts, and are dated 2001. Whether they are sanitary or storm sewers is unknown, but descriptions of the sanitary sewer do not indicate that sanitary sewers are located here.

All of the lookouts containing these sewer manholes have been raised considerably above the path level, which indicates that flooding might be expected in the area.

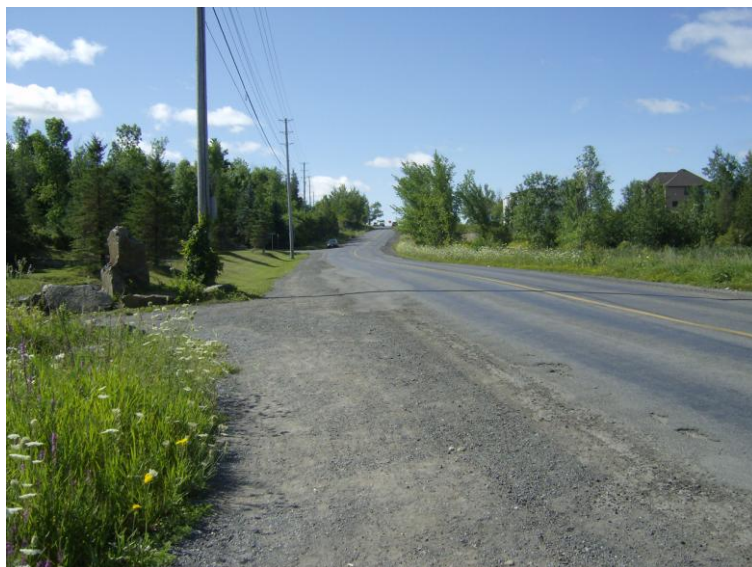
GFR Hill to the north with sloped road shoulders
