**Kizell Wetlands, Beaver Pond Wetlands and Beaver Pond
Issues and Stormwater Infrastructure Review**

Faith Blacquiere
2 Aug 2010

Kizell Wetlands, Beaver Pond Wetlands and Beaver Pond Issues and Stormwater Infrastructure

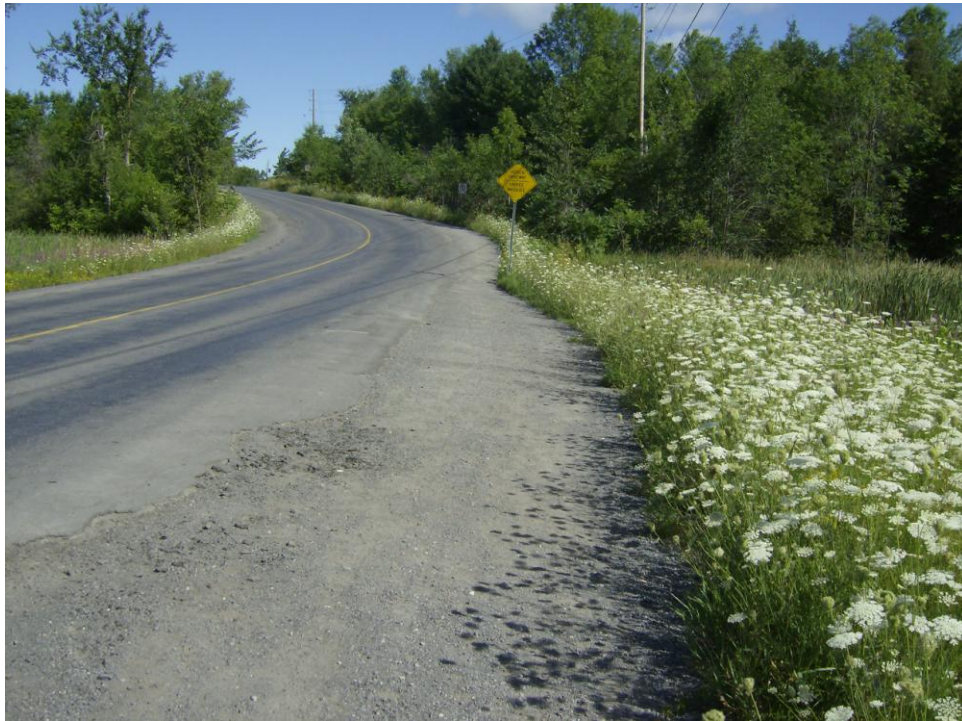
GFR hill to the north; sloped road shoulders drain to Beaver Pond

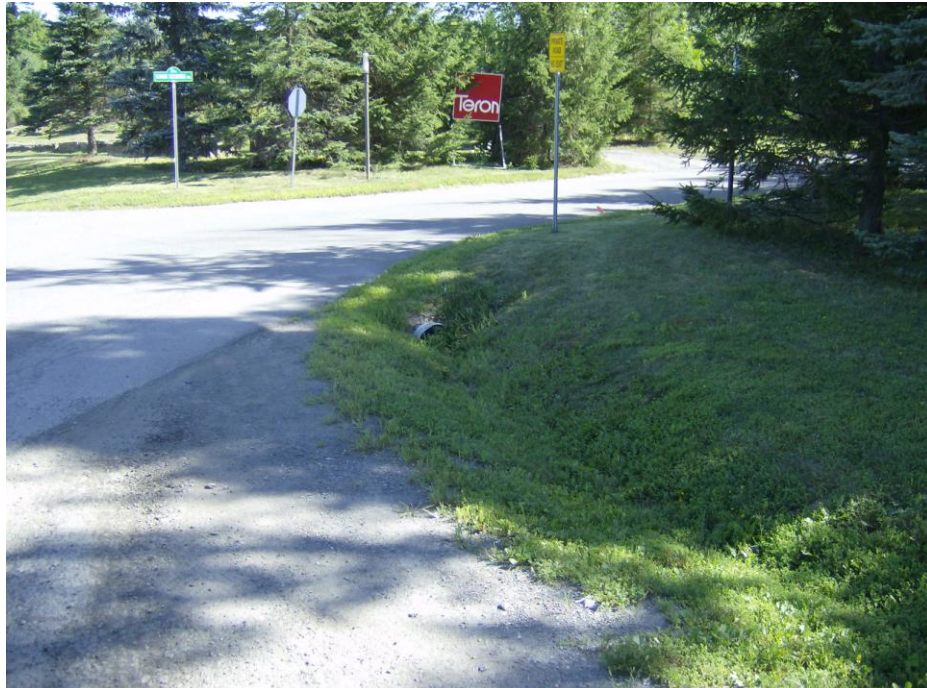
Culvert in GFR east-side ditch goes under the private road

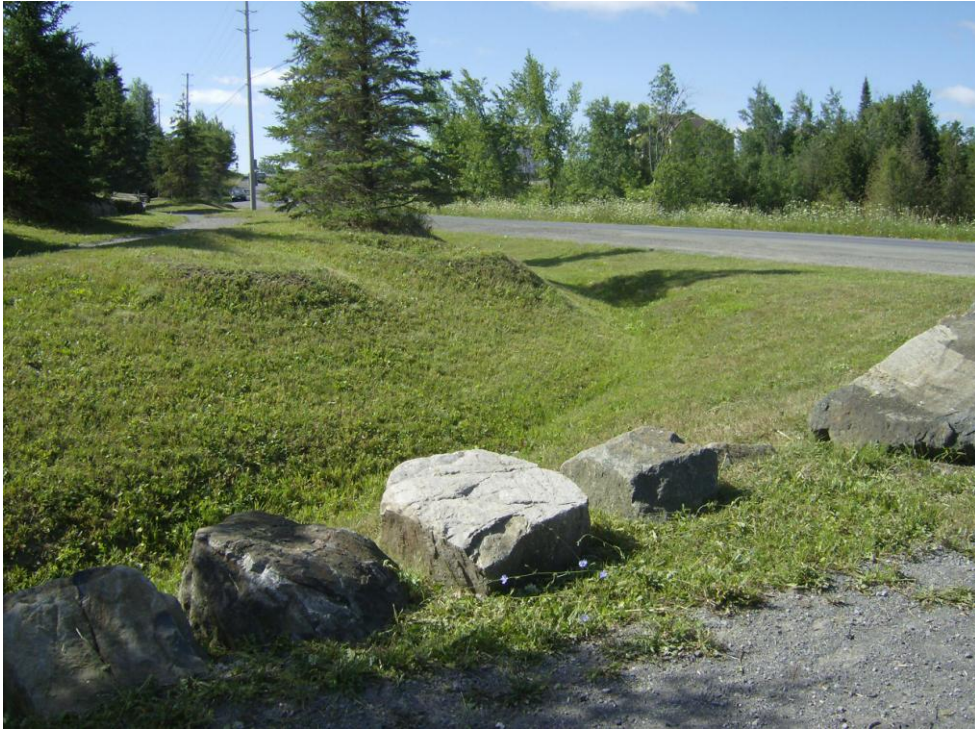
GFR east side ditch adjacent to The Rockeries. Flow is coming down the ditch system from the top of the south GFR hill

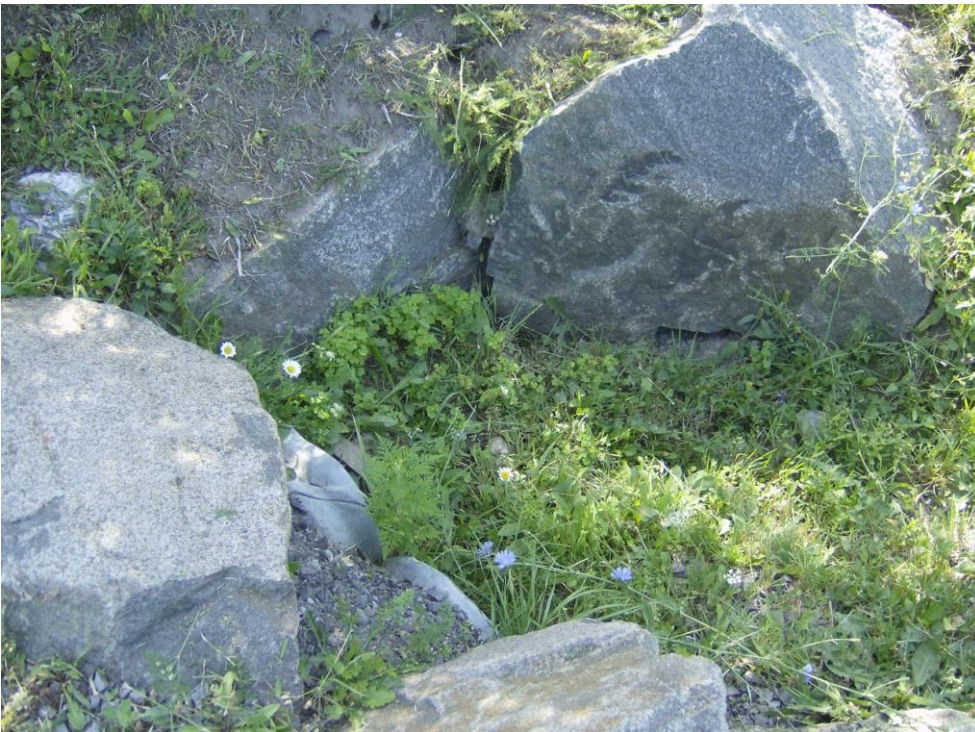
Twin CSP culverts at the pathway receive stormwater from the east side GFR ditch. Ponding would occur here in extreme events.

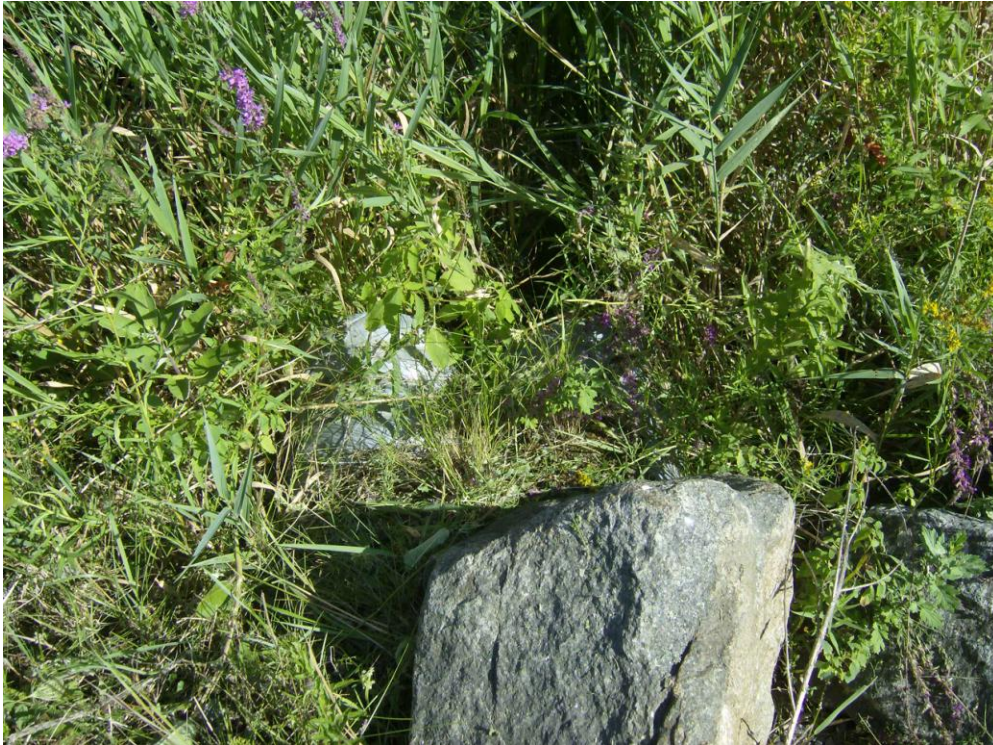
Twin culverts (the one on the right is hidden) on the Beaver Pond side receive flow from the GFR east side ditch

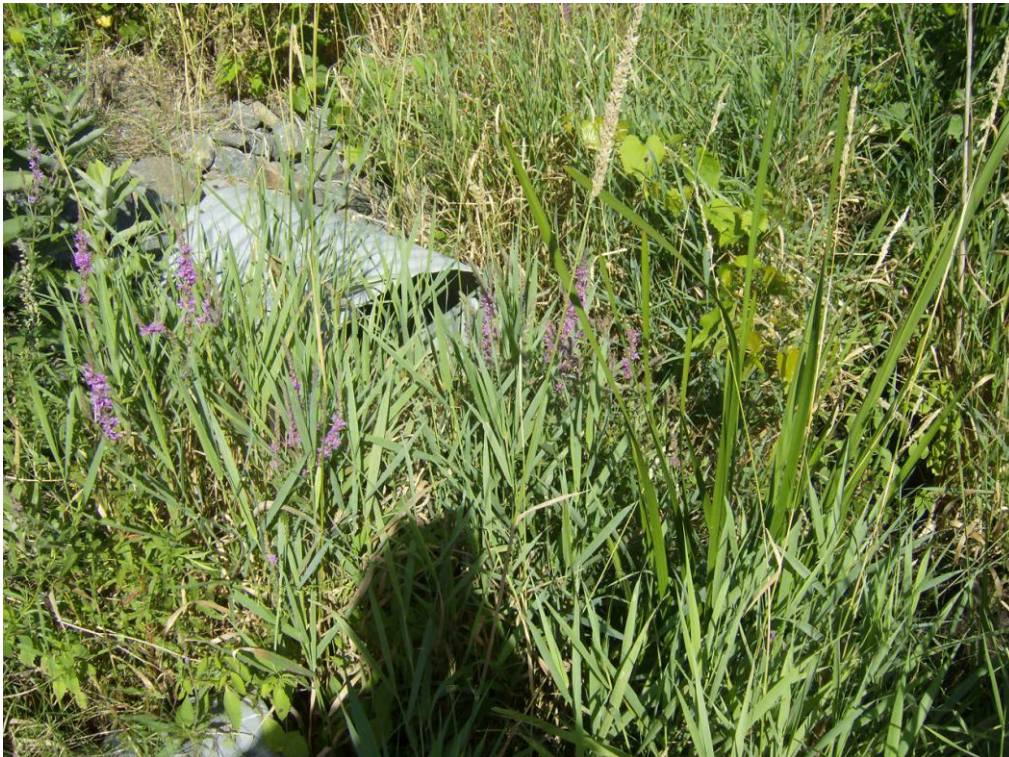
The water level was very low on 29 July 2010, however water marks on the insides indicated that the water level would normally be a few inches higher, reducing the culvert's capacity for extreme wet weather flow. It is not known whether the culvert was laid flat to be able to use its full capacity. This is an extremely small culvert considering the amount of water upstream, and it drastically restricts the flow between the two wetlands.

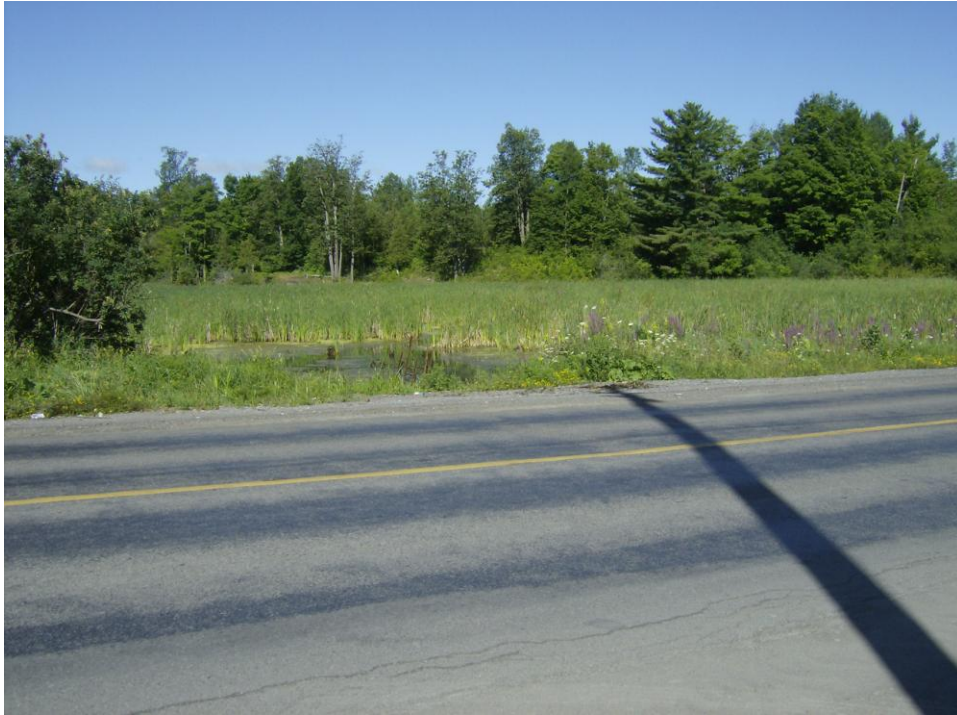
This photo shows the 29 July 2010 water level in the Kizell Wetland in comparison to the GFR road level, and also the amount of open water in Kizell Wetland..
