Upper Pool e Creek Wetl and Complex Current Conditions

Culvert along Trans Canada Trail

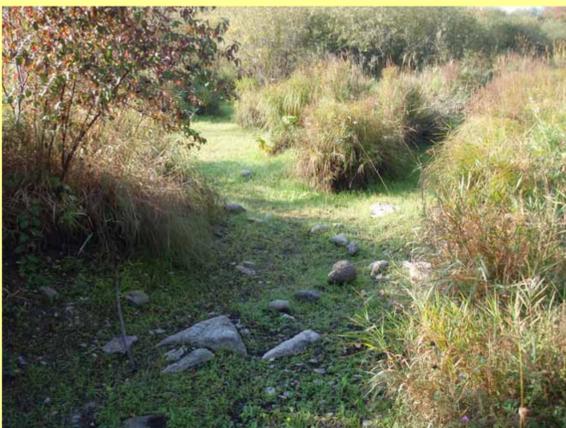
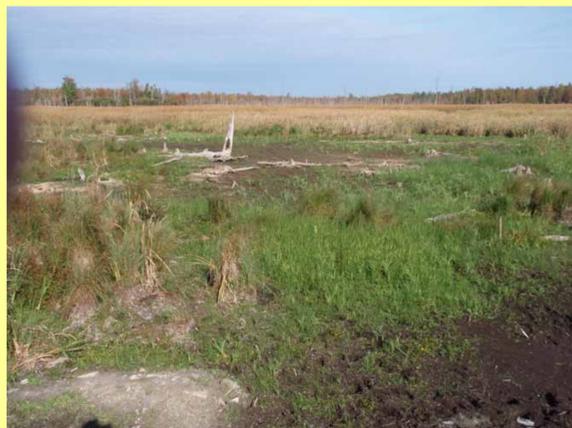
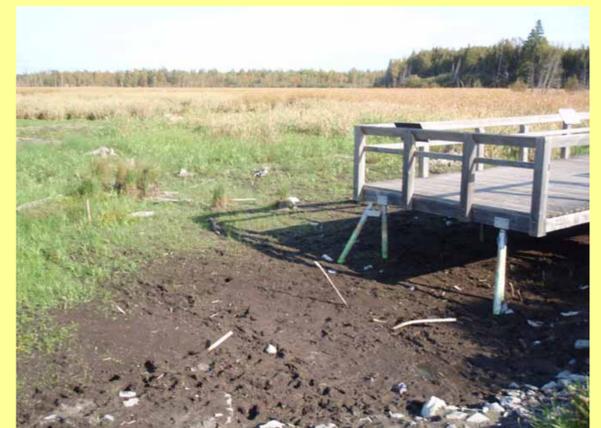
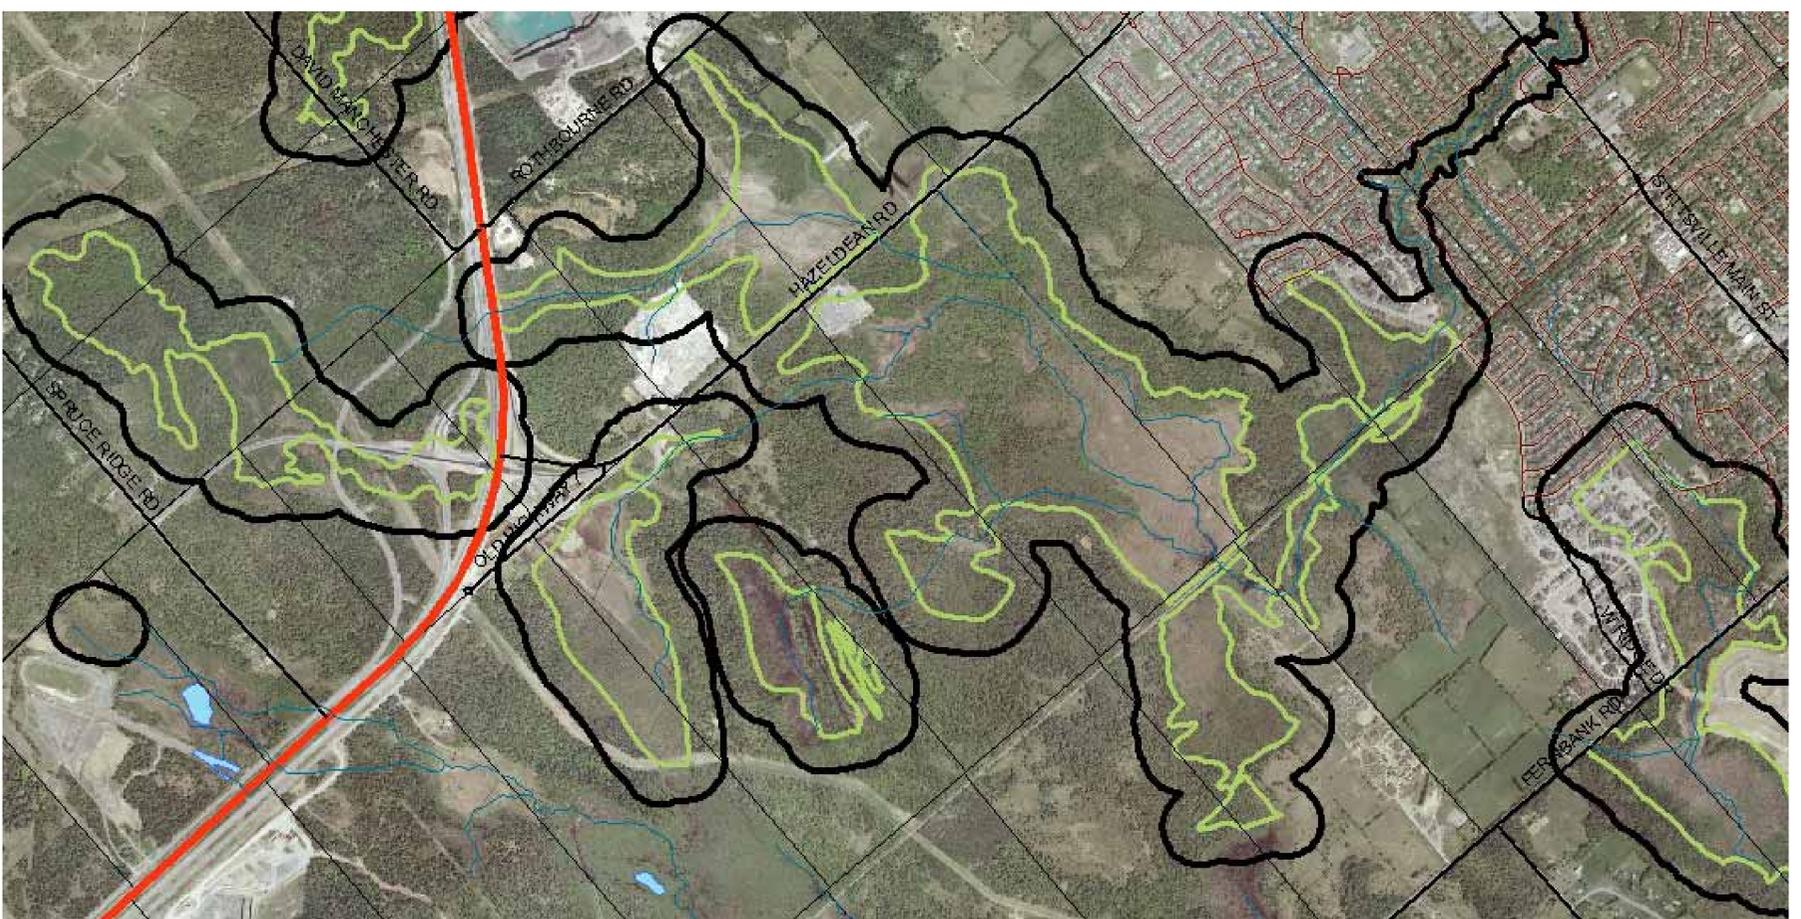
The culvert is located approximately 1100 m west of the eastern trail entrance. The equalizer connects the northern part of the marsh to the southern part of the marsh and is situated on the main waterway. It consists of a 4-foot steel culvert, the bottom of which is partially filled with soil and gravel. The present culvert was installed in the fall of 2010 to replace an older culvert of similar diameter. The elevation of the replacement culvert is reported to be somewhat higher than the previous structure.

During a site inspection conducted on September 24, 2011 it was noted that with the exception of a small puddle the culvert as well as the incoming and outgoing stream were found to be dry. Several green frogs, a juvenile bullfrog and some stressed central mudminnows were found in the puddle. The marsh upstream was found to be dry. The marsh downstream was similarly found to be dry.

The fact that cattail marsh is situated on either side, upstream as well as downstream of the equalizer culvert, indicate that the culvert was not the control feature for either side of the cattail marsh. It was determined that the present dry condition of the marsh was not influenced by the culvert replacement because both sides appear equally dry at the present time, and since the current culvert invert is reported to be situated at a slightly higher elevation than the previous one. The downstream marsh leads into a shrub-and-brush swamp. This suggests that the former beaver dams had not been the major water level control feature for the marsh 700 m upstream.

It follows that the current absence of water in the wetland is due to causes other than the maintenance work of 2010.
